CLACKMANNANSHIRE COUNCIL

River Devon at Elistoun Drive, Tillicoultry 25/01/08

BIENNIAL REPORT – November 2007
As required by
THE FLOOD PREVENTION AND LAND DRAINAGE
(SCOTLAND) ACT1997

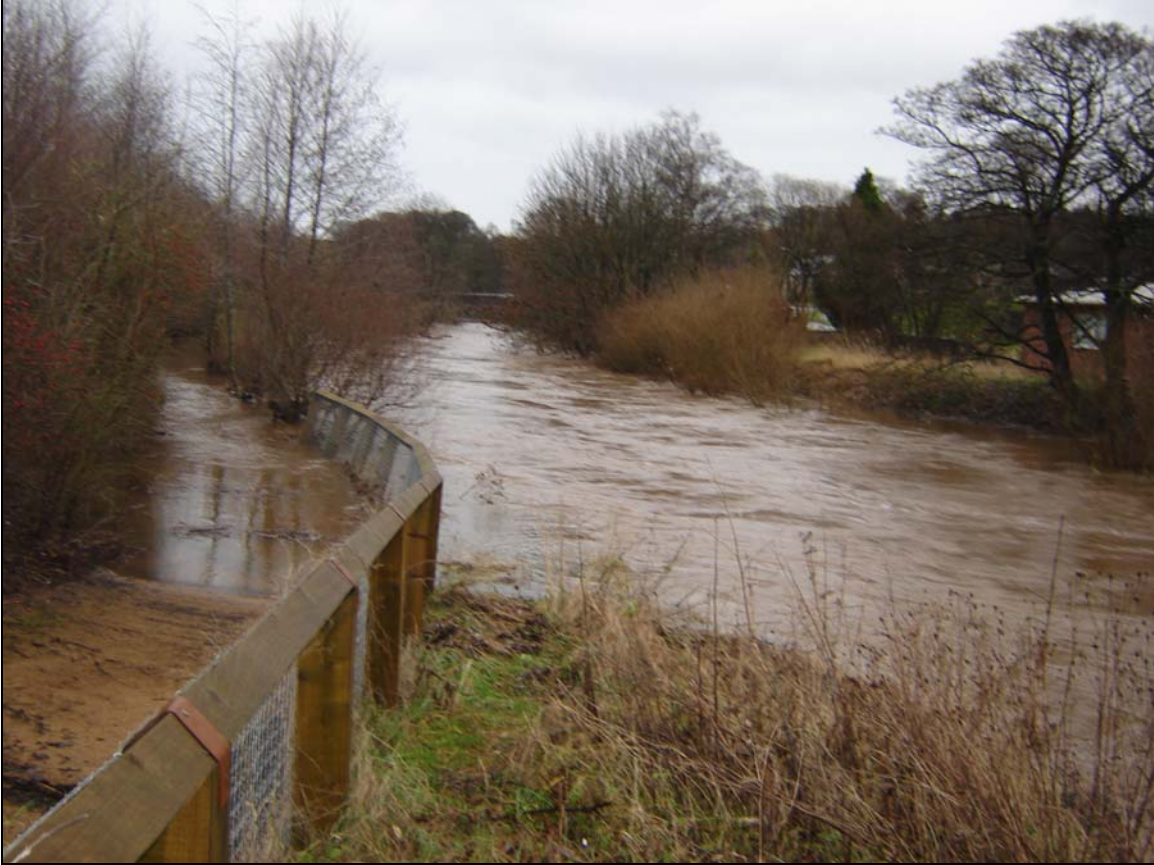
Photo 1 – River Devon over tops its north bank at Sterling Mills, Tillicoultry – 14/12/06

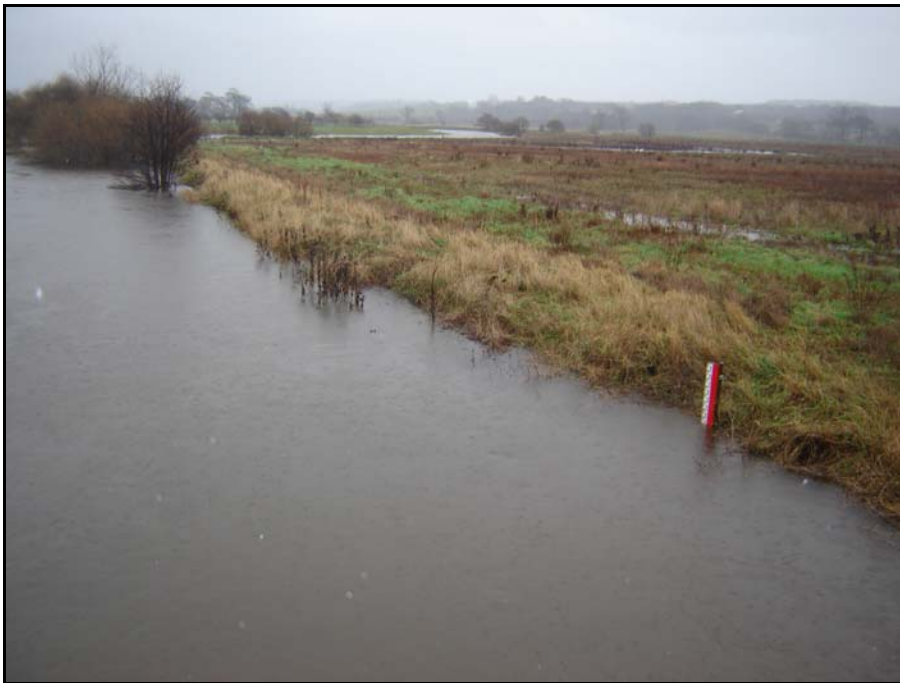
Photo 2 – High River Levels on the River Devon south of Alva – 13/12/06

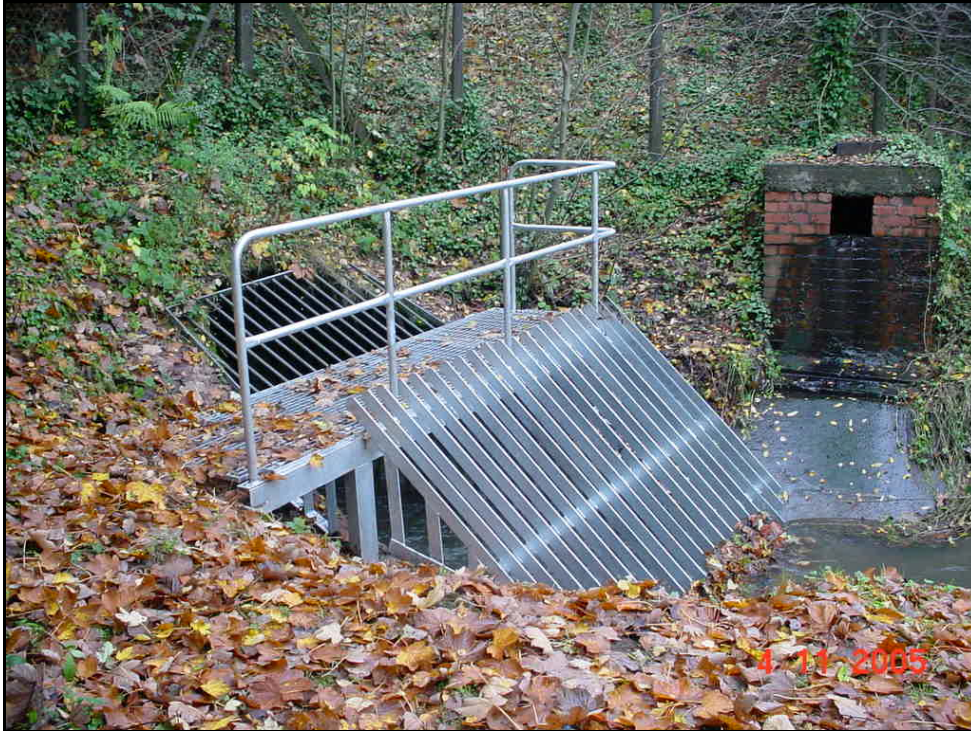
Photo 4– Brothie Burn Trash Screen at Shillinghill Culvert, Alloa

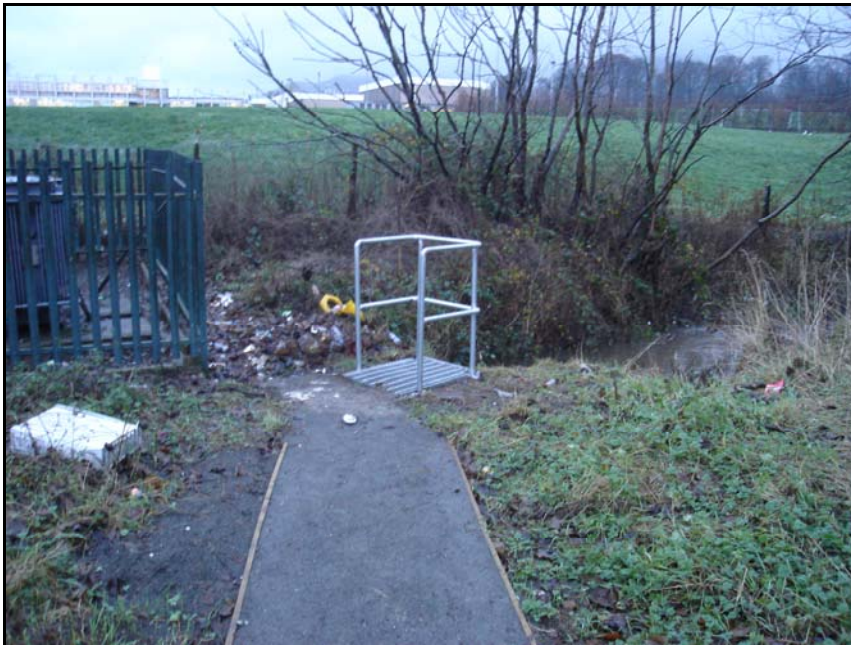
Minor problem arose when the trash screen blocked and watercourse over-flowed to garage area. Watercourse ref. U-02.

Photo 5 - Trash Screen, handrail and access installed at culvert entry north of Ormiston Drive, Alloa - 12/12/06

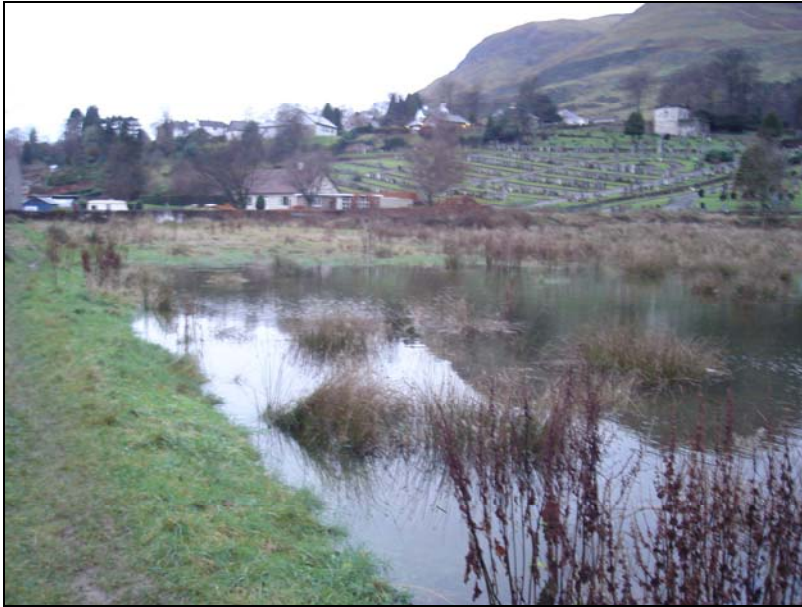
AV-10 Rhodders Grove (NS 889 971)

13-15/12/06 Flood flows from blocked watercourse flowed towards bog area and threatened houses to south. Watercourse ref. U-22

Photo 6 - Flooding to north of Properties at 41 to 55 Rhodders Grove, Alva – 14/12/06

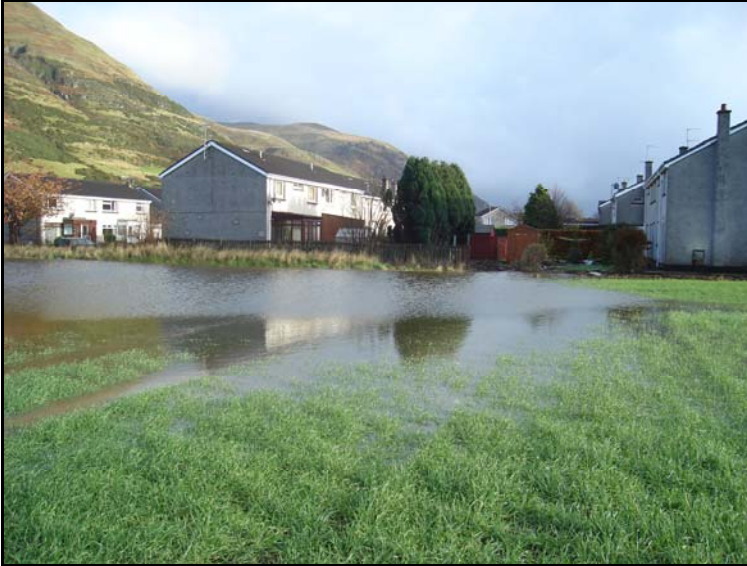
AV-13 Cleuch Drive (NS871 971)

17-20/11/06 Over-land flows affected garden ground of houses on urban / rural boundary during heavy rain fall event.

Photo 7 - Overland flow affecting Cleuch Drive, Alva – 20/11/06

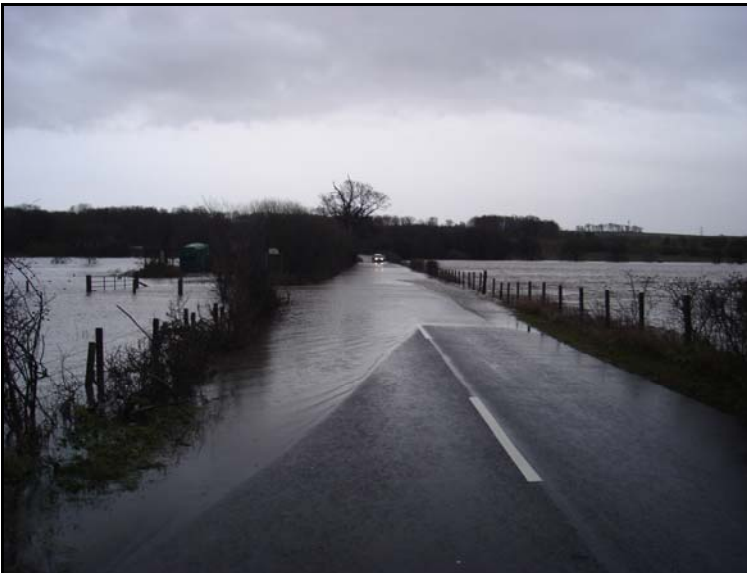
AV-14 B908 (Section between Junction with A91 and River Devon Road Bridge)

13-17/12/06 Flooding to public road due to operation of River Devon floodplain. Road closed during period. Watercourse ref.R-01

Photo 8 - B908 inundated by River Devon floodplain – 14/12/06

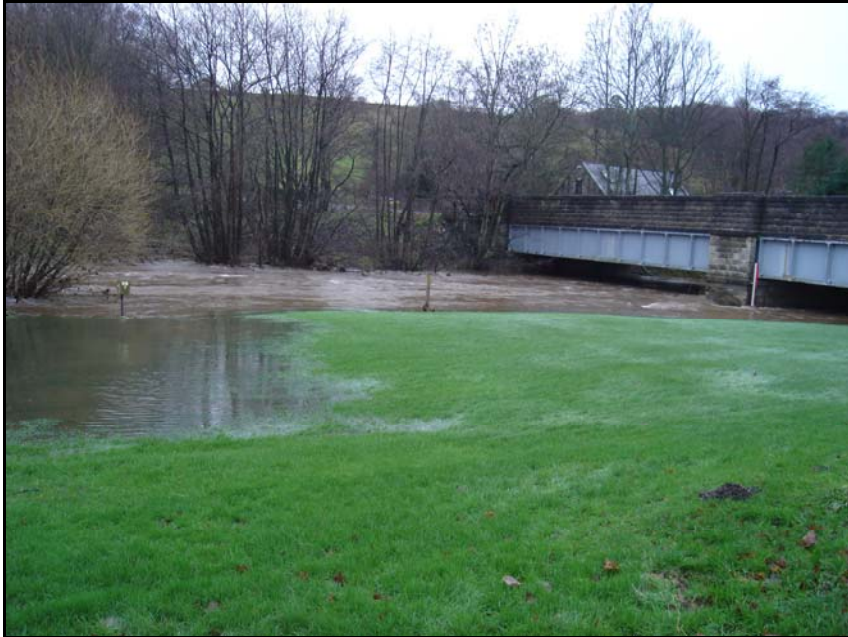
DL-04 Caravan Site, Rackmill (NS 962 969)

13-14/12/06 Minor amount of floodwaters from the River Devon reached the caravan site. The site is located on the operational floodplain of the river. No reports of any damage. Watercourse ref. R-01.

Photo 9 - River Devon, Rackmill Caravan Site, by Dollar – 14/12/06

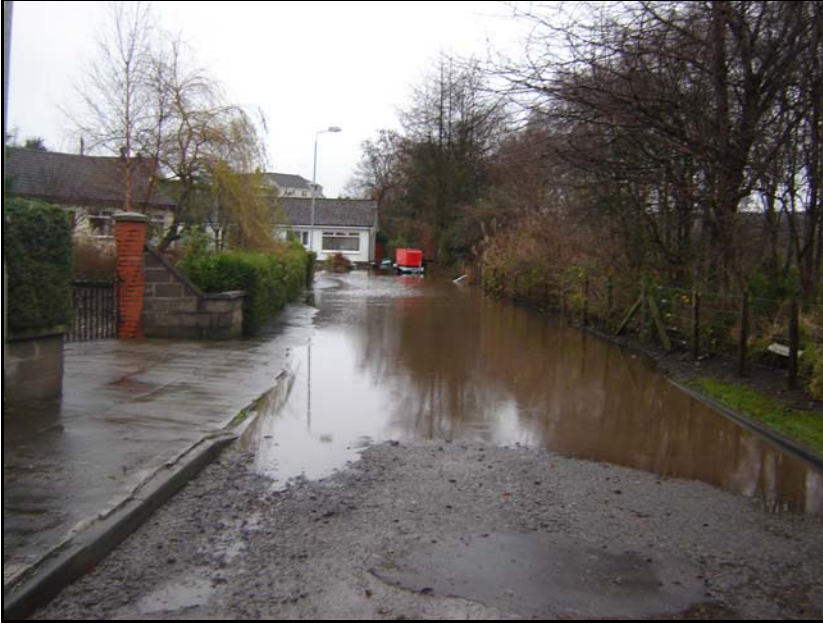
13-15/12/06 Flooding to houses (nos. 6 an 8) Drive due to surcharging of drainage system, due to lack of system capacity and high river levels at outlet. Watercourse ref. R-01 and U-08.

11/01/07 Flooding to private road due to surcharging drainage system. Watercourse ref. R-01 and U-08.

Photo 10 - Flooding of Elistoun Drive, Tillicoultry – 14/12/06

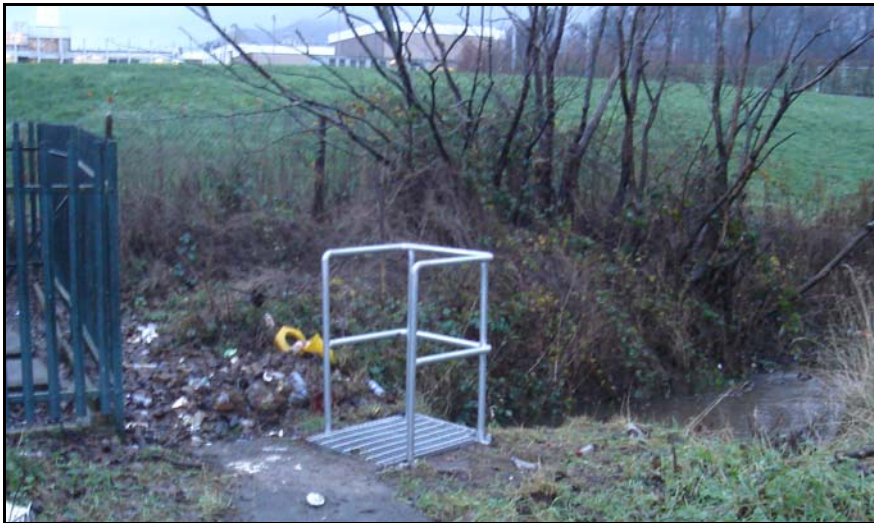
AL-06 Ormiston Drive (NS 874 945)

17/11/06 Minor blockage due to collection of urban and rural debris at former trash screen. New trash screen, handrail and access footpath installed from road, 11/12/06. Watercourse ref. U-02.

Photo 11 - New Trash screen, handrail and access footpath at Ormiston Drive, Alloa – 12/12/06

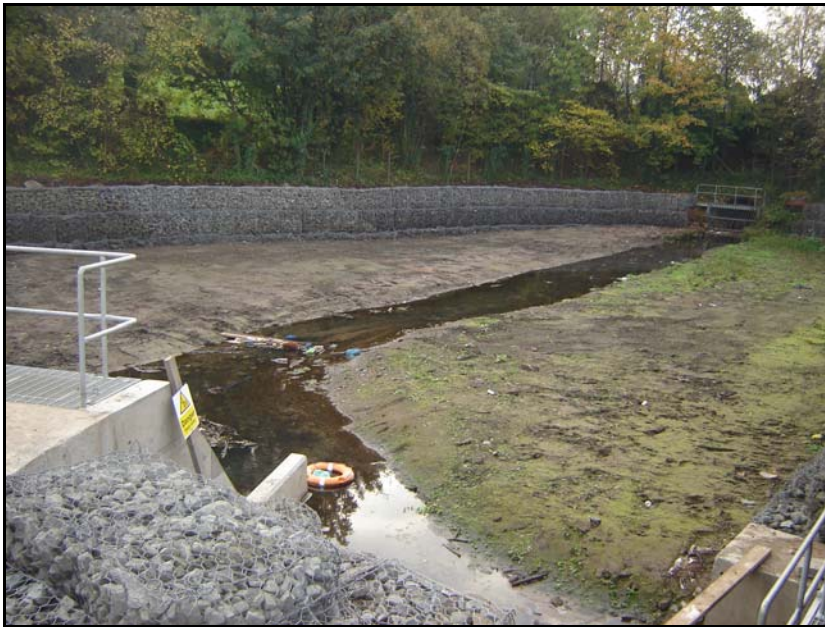
AL-09 New Aldi Store Site (NS 890 930)

Site recently re-developed as an ALDI superstore. Brothie Burn diverted to new 4m x 2m culvert structure. Detailed design of inlet and outlet screens, new flood storage pond and culvert maintenance programme (adopted by developer) agreed with developer October 2007. Acquisition of Controlled Activities Regulation approval also still to be sought by developer from SEPA. No flooding recorded since November 2005.

Photo 12 – New holding pond (ALDI site) on the Brothie Burn at Shillinghill 25/10/07

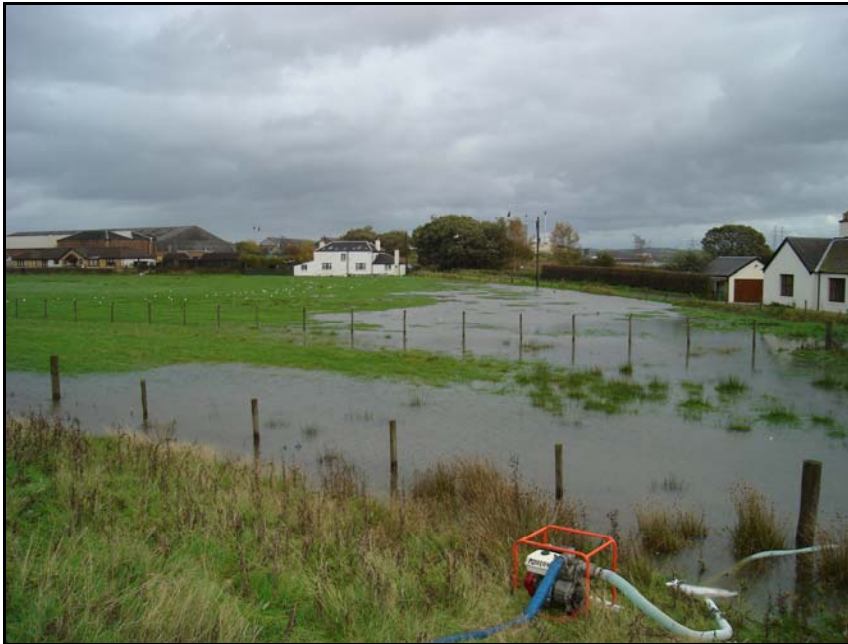
19-20/01/07. Flood threat to houses occurred apparently as a consequence of heavy storm events generating over-land flows from fields and also due to apparent non-operation of emergency pumps associated with a nearby surface water pump station / pond. Pump management system re-evaluated and management agreement system in place.

Photo 13 - Flooding from watercourse resulting in over land flow threat to Longcarse Farm, Alloa – 26/10/06

Pump Station pumps checked and now operational. Remote failure alarm system to be operational end of 2007.

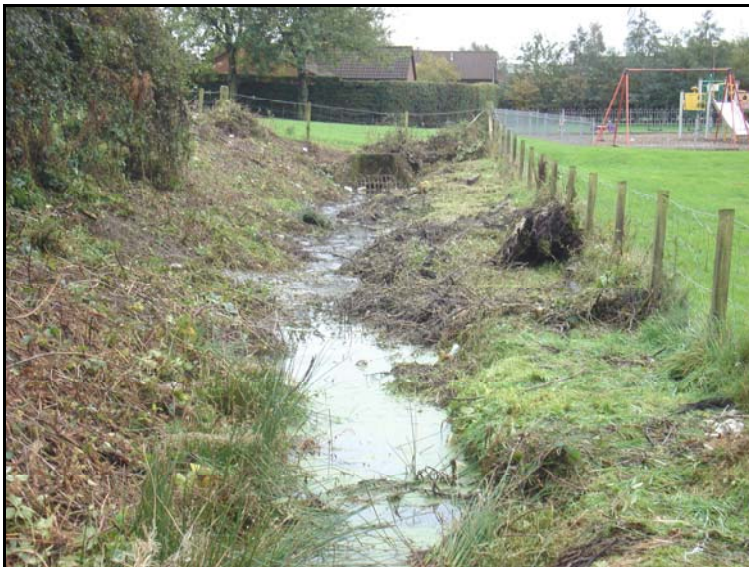
AV-10 Rhodders Grove (NS 889 971)

13-15/12/06 Watercourse became blocked at watercourse inlet trash screen. Resultant flood flows gathered at bog area to west of inlet resulting in a build up of ponding water which threatened houses to south of bog area. Watercourse U-22. Partial blockage within underground culverted watercourse system to south of inlet cleared and newly found manholes on system cleared and brought to surface.

Photo 14 - Watercourse clearance and culvert system upgrade works, east of Rhodders Grove, Alva – 25/10/06

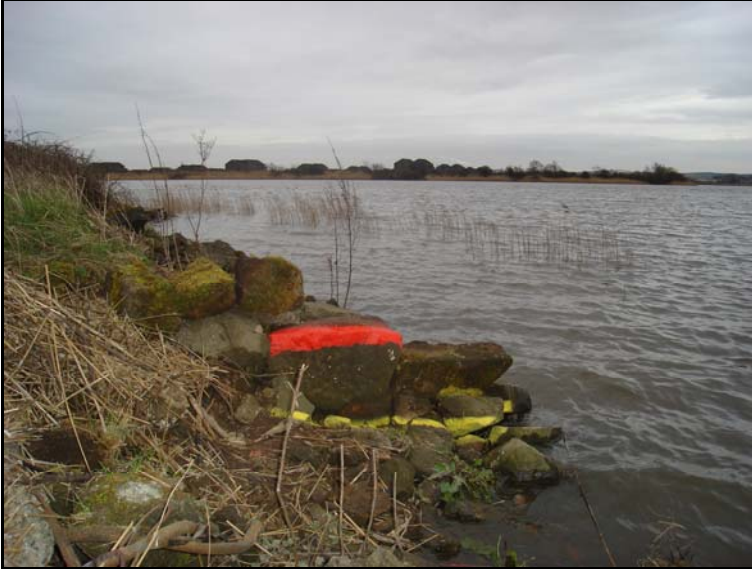
Photo 15 – High and low water marks on the River Forth at Cambus - 21/03/07

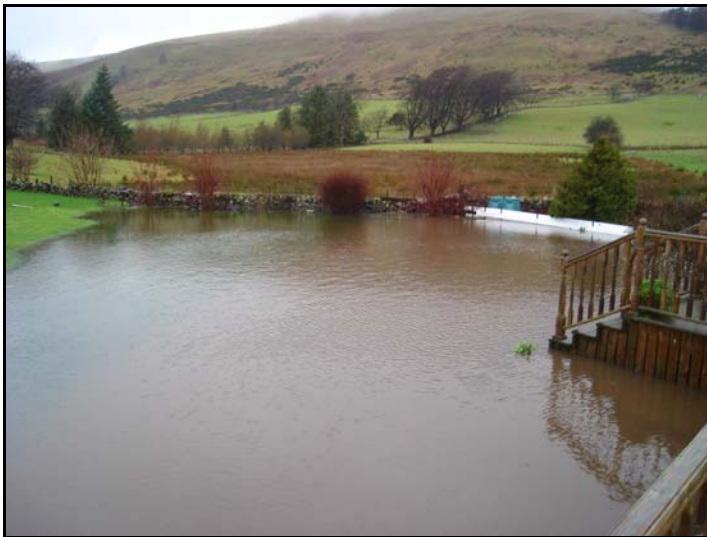
& 12/01/07 Flood to garden ground and foundations of number 7 Kirkhill. 13-14/12/06 storm event primarily due to new fence line constructed across watercourse by resident. Fence cut by Council staff during emergency works to relieve flood.

12/01/07 Flood during this storm event caused by partial blockage of culvert at headwall entry point south of number 7. New trash screen installed at headwall February 2007. Watercourse ref. U-13.

Photo 16 - Flooding to Properties at Kirkhill, Muckhart from watercourse to north – 12/01/07

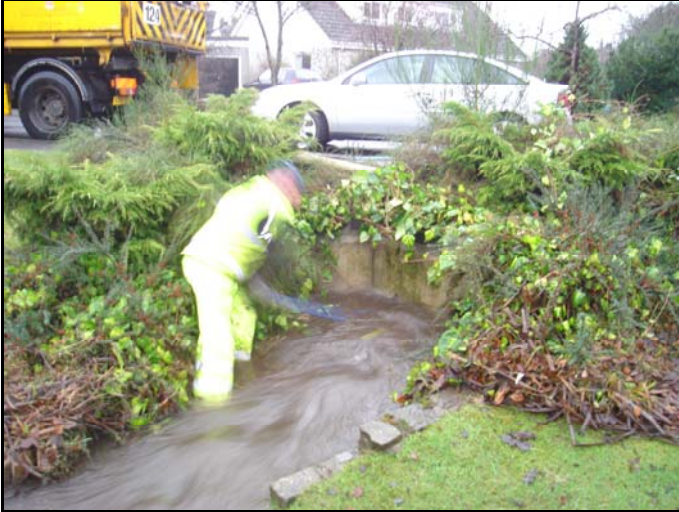
Photo 17 – Flooding issue being resolved by Council staff at Kirkhill, Muckhart – 12/01/07

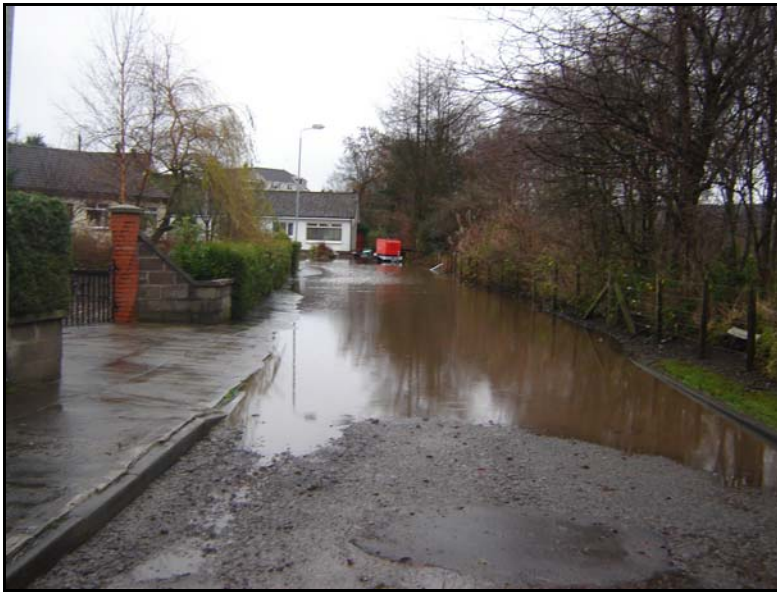
13-15/12/06 Flooding to property (nos. 6 and 8 Elistoun Drive) due to surcharging of drainage system, due to lack of system capacity and high river levels at outlet. Watercourse ref. R-01 and U-08.

11/01/07 Flooding to private road due to surcharging drainage system. Watercourse ref. R-01 and U-08.

Photo 18 – Flooding of Elistoun Drive, Tillicoultry – 14/12/06

The event of 13-15/12/06 resulted in considerable flooding to property at 6 and 8 Elistoun Drive and required emergency intervention by the Fire Service, Council staff and Scottish Water. Further temporary measures were employed to protect the site until a more permanent scheme could be installed. Detailed hydrological and hydraulic investigations of the area have been jointly undertaken by Scottish Water and the Council (*“Elistoun Drive Flood Alleviation Study–June 2007”*)⁷ in order to identify the nature of the mechanisms which can lead to flooding at this location. Agreement has recently been reached between both parties to jointly fund a permanent engineered solution at this location to increase the level of protection against such surface water and sewer flooding.

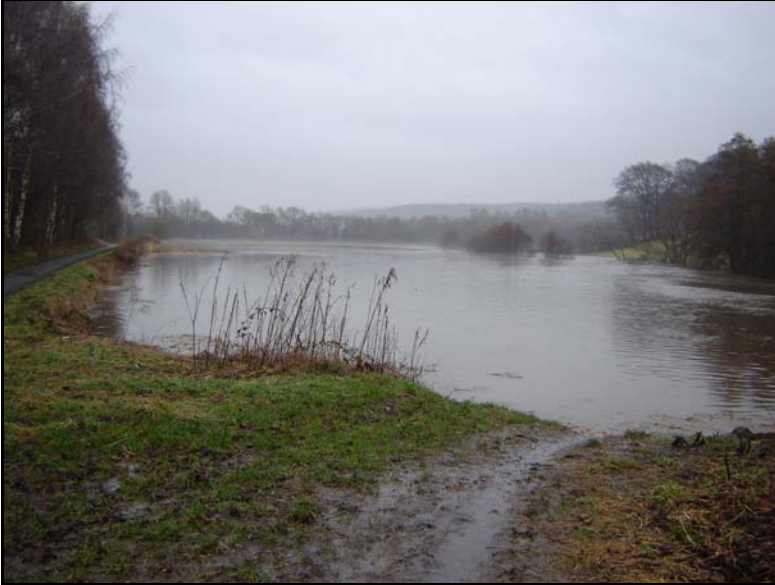
Photo 19 – River Devon Floodplain in operation at Elistoun Drive – 27/03/06

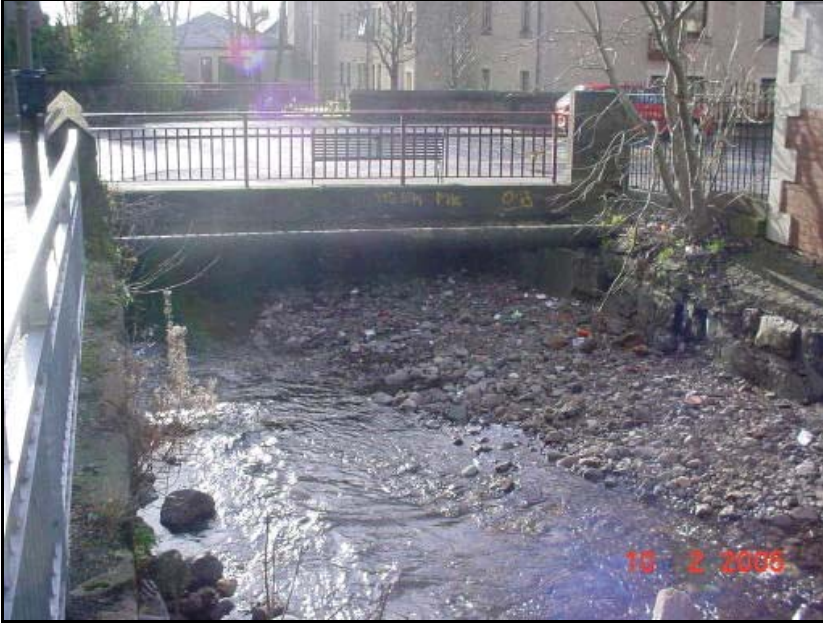
Areas where excessive coarse sediment gathers may also create snagging points for vegetation and other debris creating dams and changing the flow line.

Photo 20 – Excessive build up of Sediments upstream of and beneath the A91 Road Bridge, Alva Burn Alva. – 02/10/05

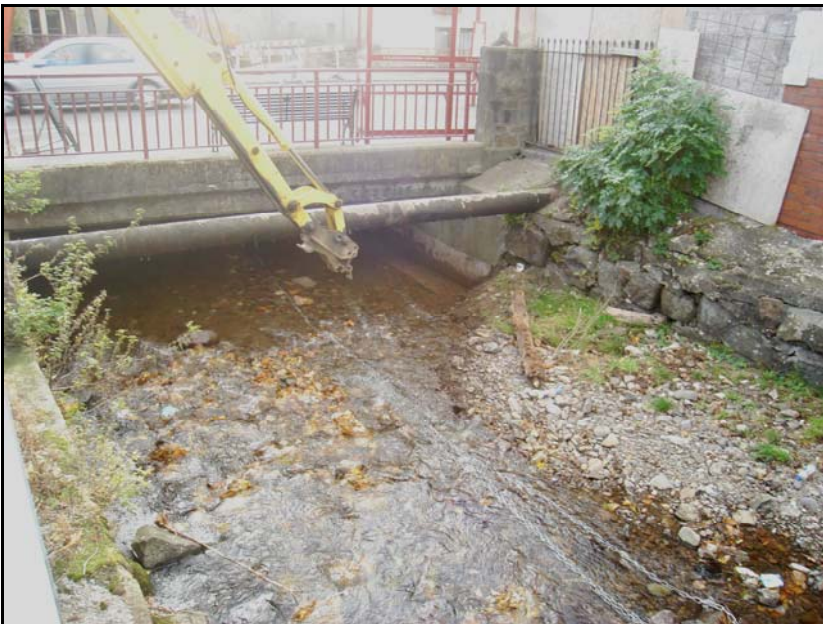
Photo 21 – “CAR” consented works to remove sediment from A91 Road Bridge, Alva Burn, Alva – 09/11/07

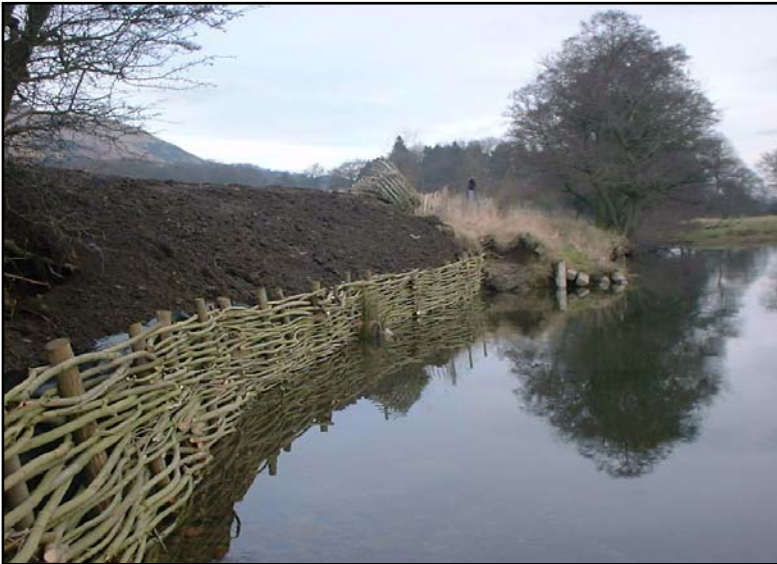
Photo 22 – Willow walling of the north bank of the River Devon between Tillicoultry and Dollar
