## 6 Summary and Conclusions

- 6.1 AECOM was commissioned by Clackmannanshire Council to undertake the measurement and assessment of vibration from rail traffic along the Stirling-Alloa-Kincardine (SAK) railway line.

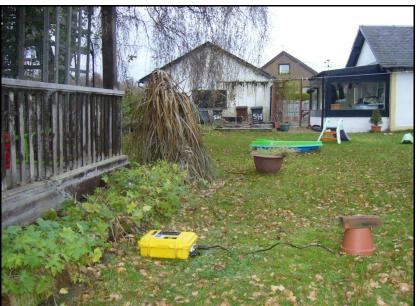
Figure 5.55: Photograph of Vibration Monitoring Equipment at Station House, Station Road, Kincardine

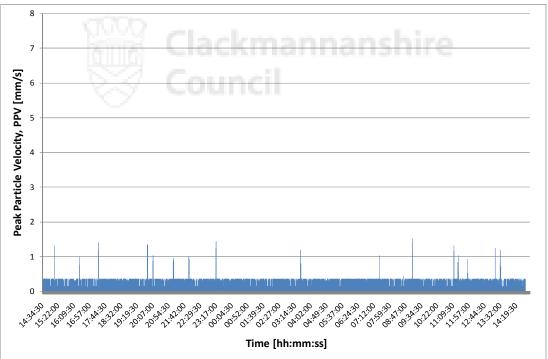
Figure 5.56: Time History of 30-Second PPVs Measured at Station House, Station Road, Kincardine

5.114 The highest measured PPV was 1.526 mm/s. This level occurred between 09:07:00 and 09:07:30 on Friday 19 November. This level is well below the criteria. It is therefore unlikely to give rise to cosmetic cracks in the dwelling, or any more serious structural effects.
