CLACKMANNANSHIRE COUNCIL

FLOOD PREVENTION AND LAND DRAINAGE (SCOTLAND) ACT 1997

BIENNIAL REPORT – November 2005

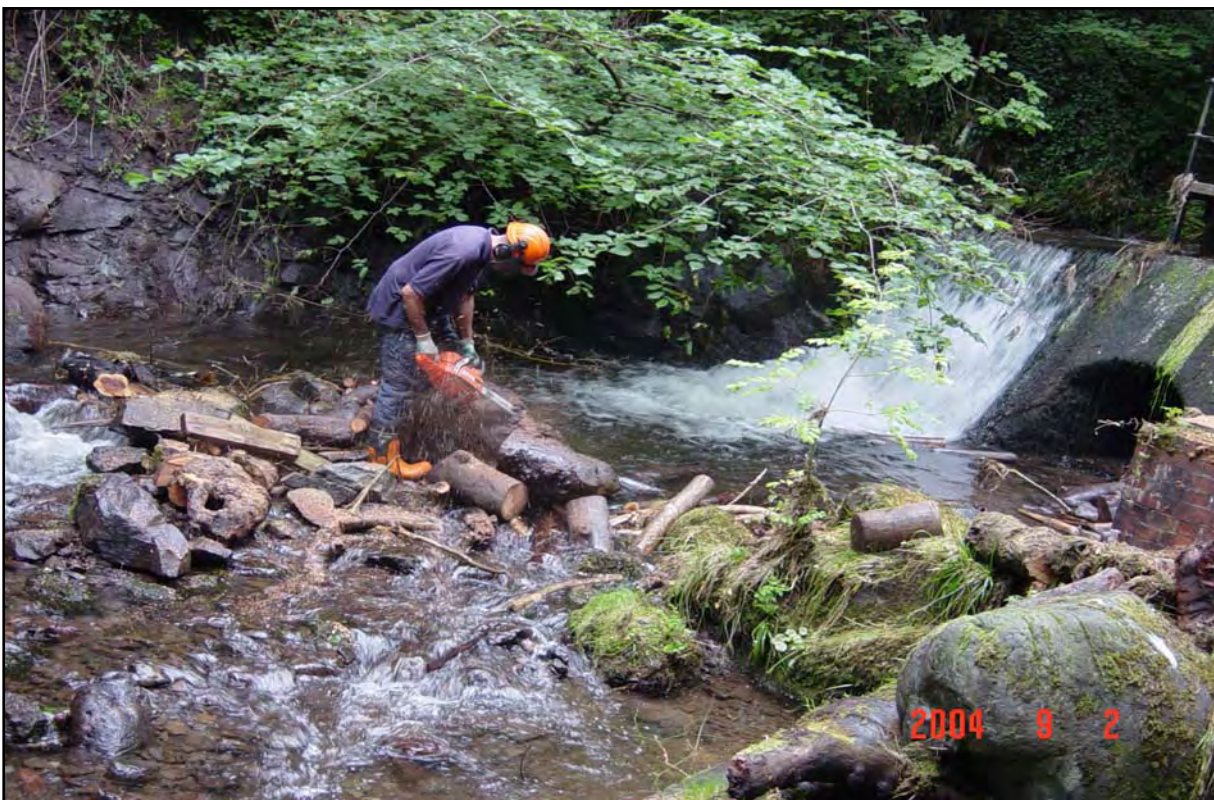
Photo 1 - Council staff carrying out dead wood debris cutting in Alva Glen

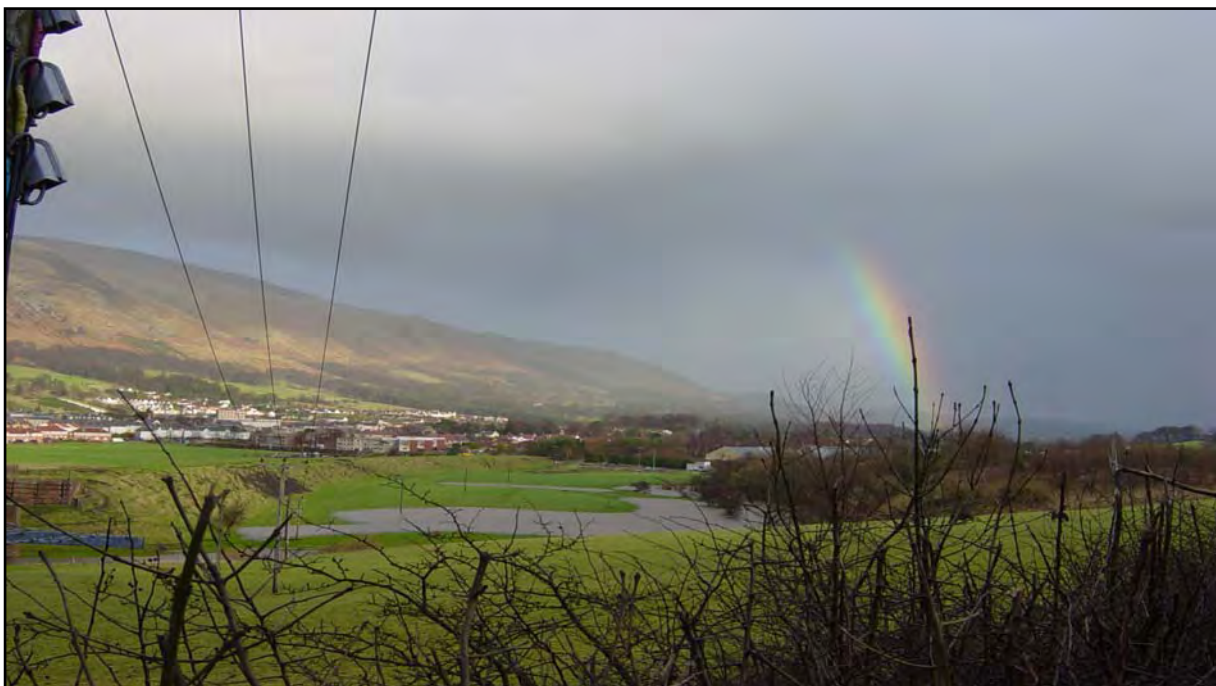
Photo 2 - River Devon looking northeast showing flood storage – 10/01/05

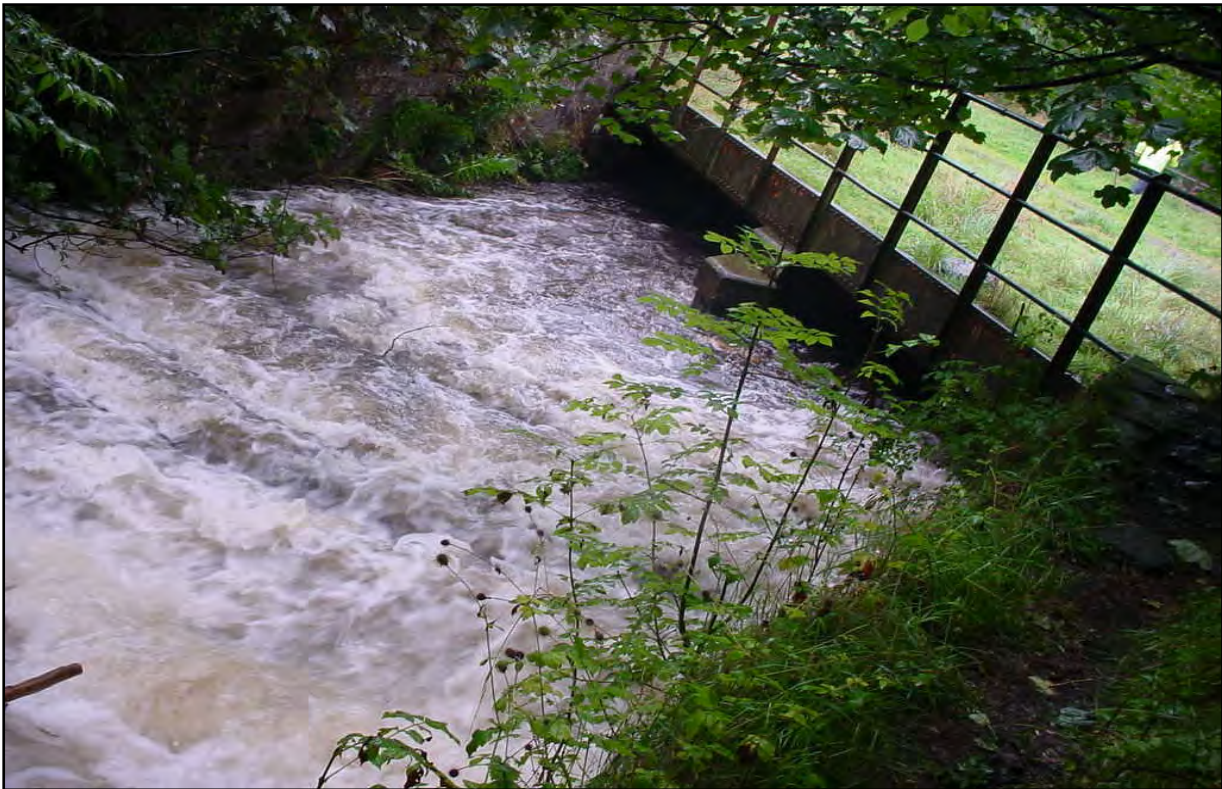
Photo 3 – Dollar Burn at Old Railway Line looking south - 10/08/04

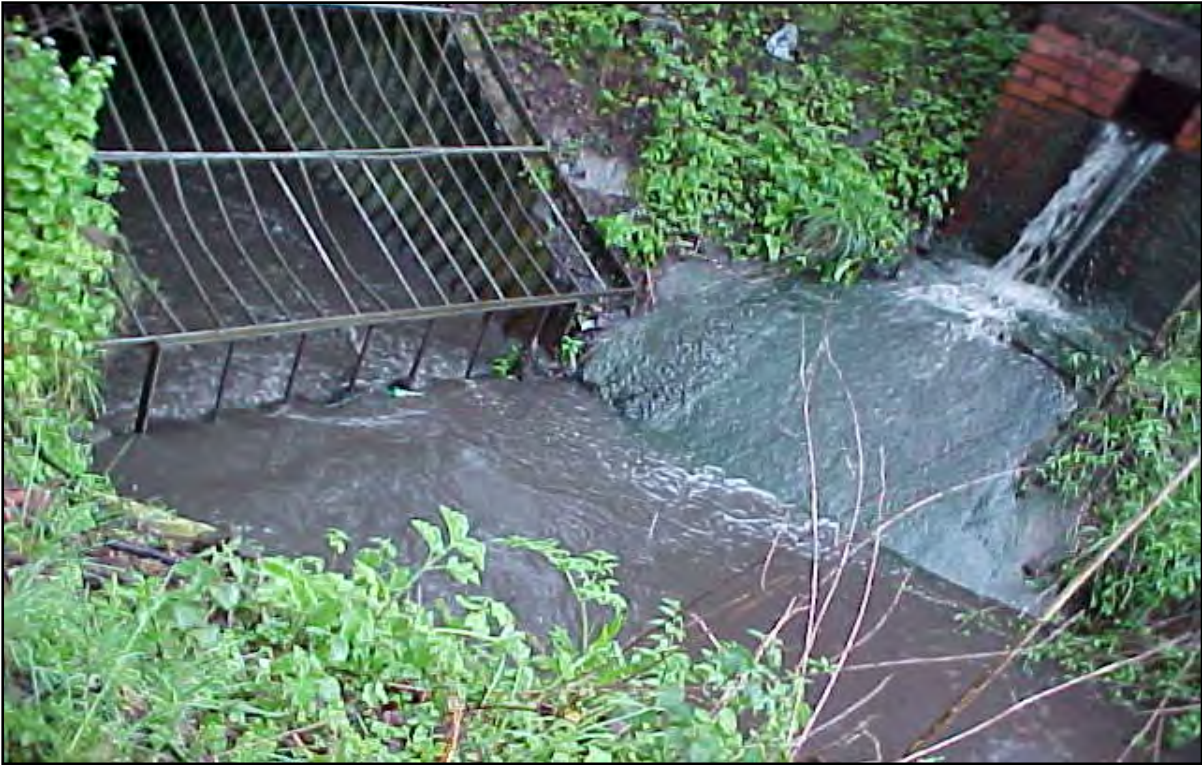
Photo 4 - Brothie Burn at Shillinghill Culvert, Alloa – 10/05/04

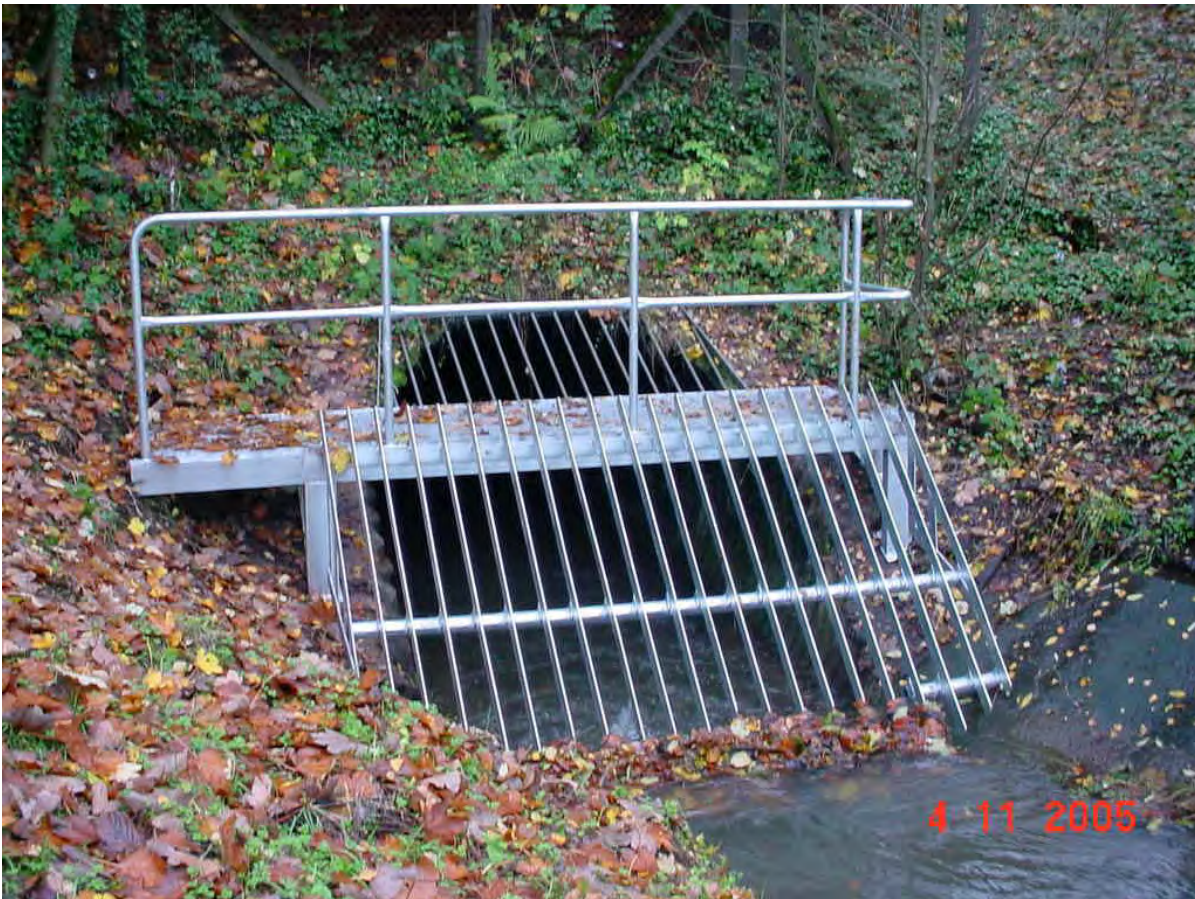
Photo 5 – Brothie Burn at Shillinghill Culvert, Alloa – recently replaced trash screen - 04/11/05

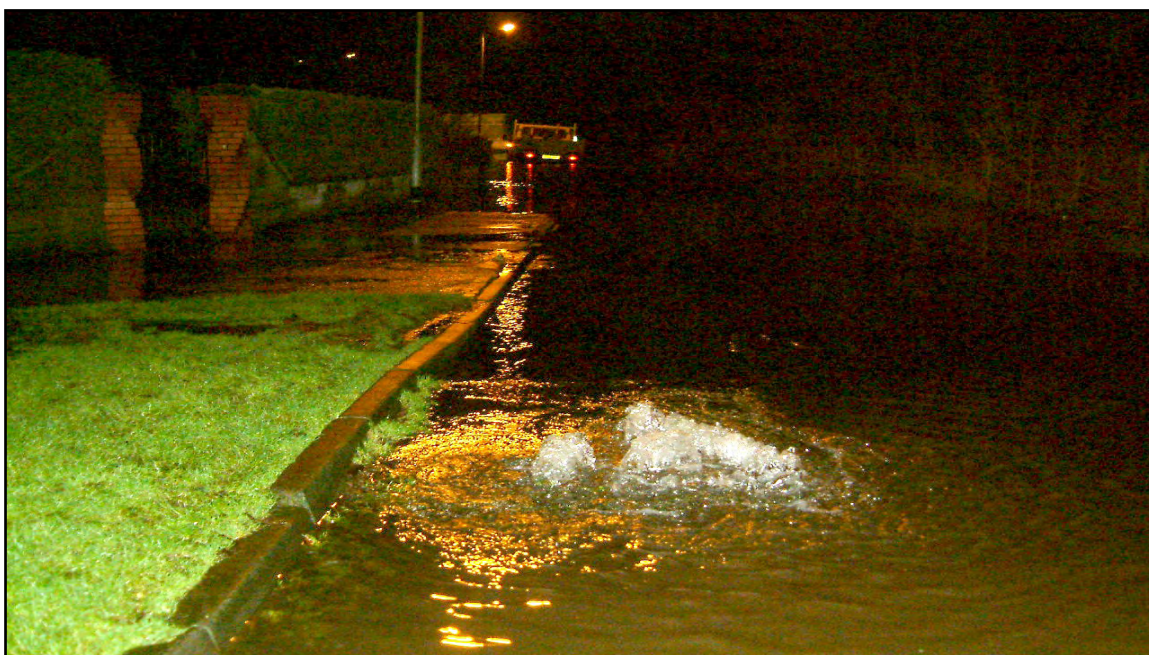
10/01/05 Flooding to 6 no. houses at the east end of Elistoun Drive. Water surcharging from piped drainage system in the road.

Photo 6 – Flooding of Elistoun Drive, Tillicoultry - 10/01/05

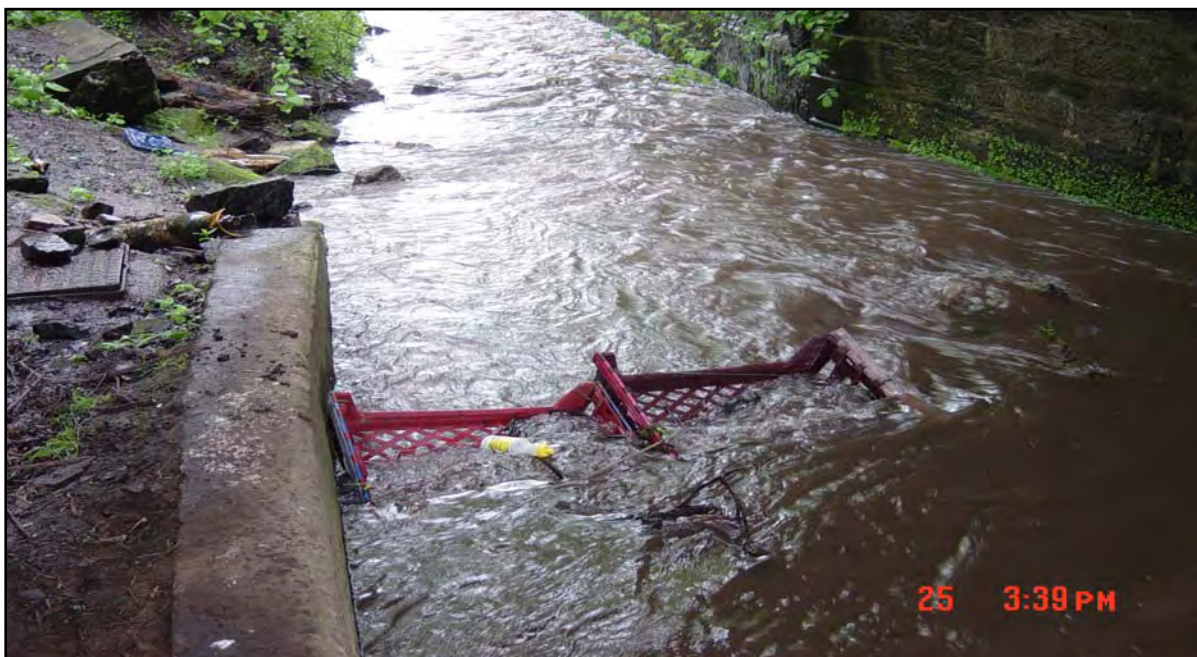
Site is prone to dumping and collection of natural debris from upstream. Due for redevelopment. Trash screens under railway bridge (NS 891 931) and at Shillinghill Roundabout (NS 889 929) were in poor condition and inaccessible.

Photo 7- Brothie Burn Alloa looking east - 25/05/05

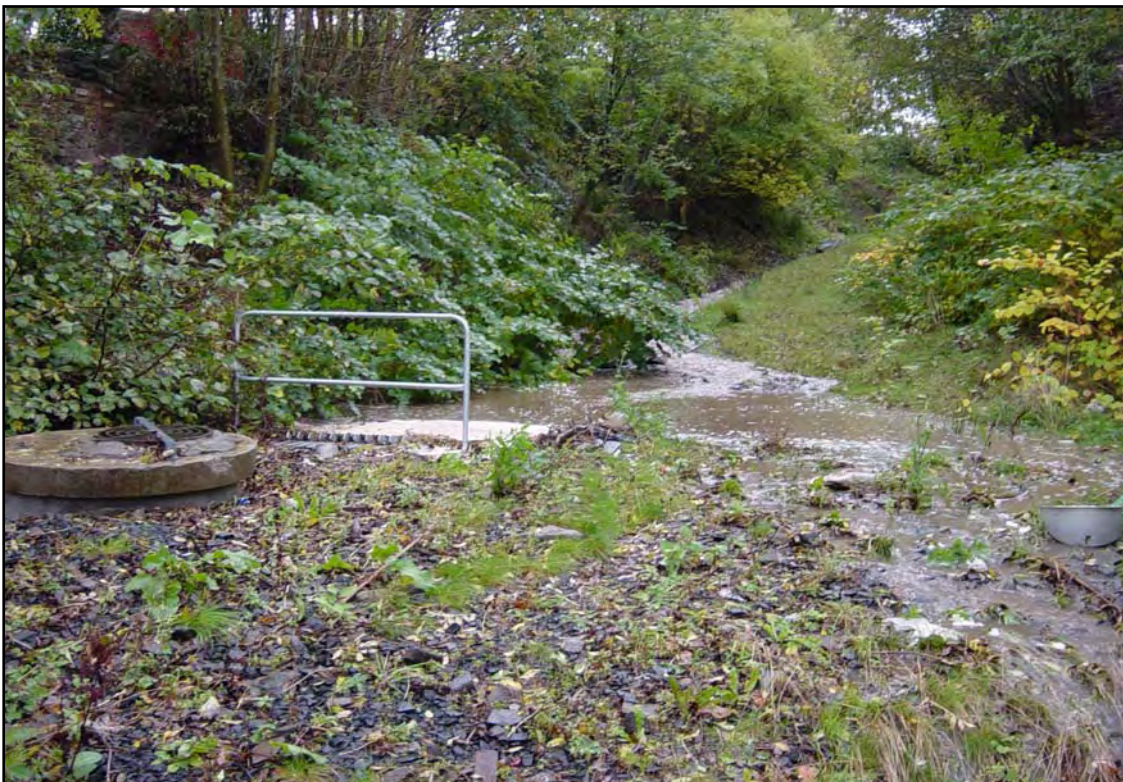
The Glen is used for fly tipping (further upstream). Combination of household rubbish and natural debris brought down the steep glen by flood waters causes blockage at poorly formed pipe inlet (culvert under A908).

Photo 8 – The Glen, Devonside - 21/10/04

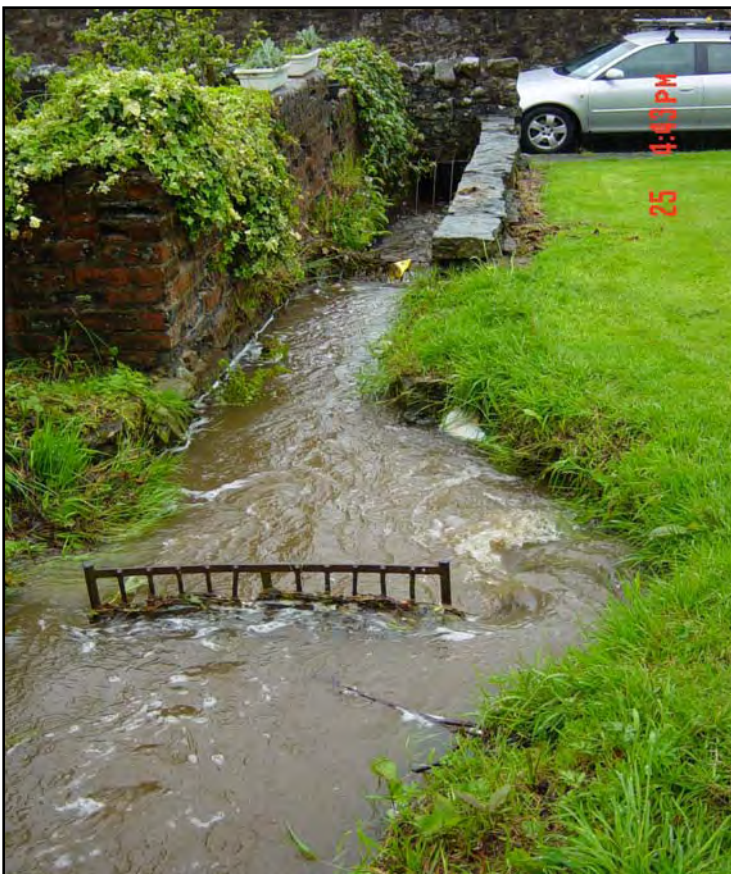
Photo 9 - The burn at Thornbank Road, Dollar looking west - 25/05/05

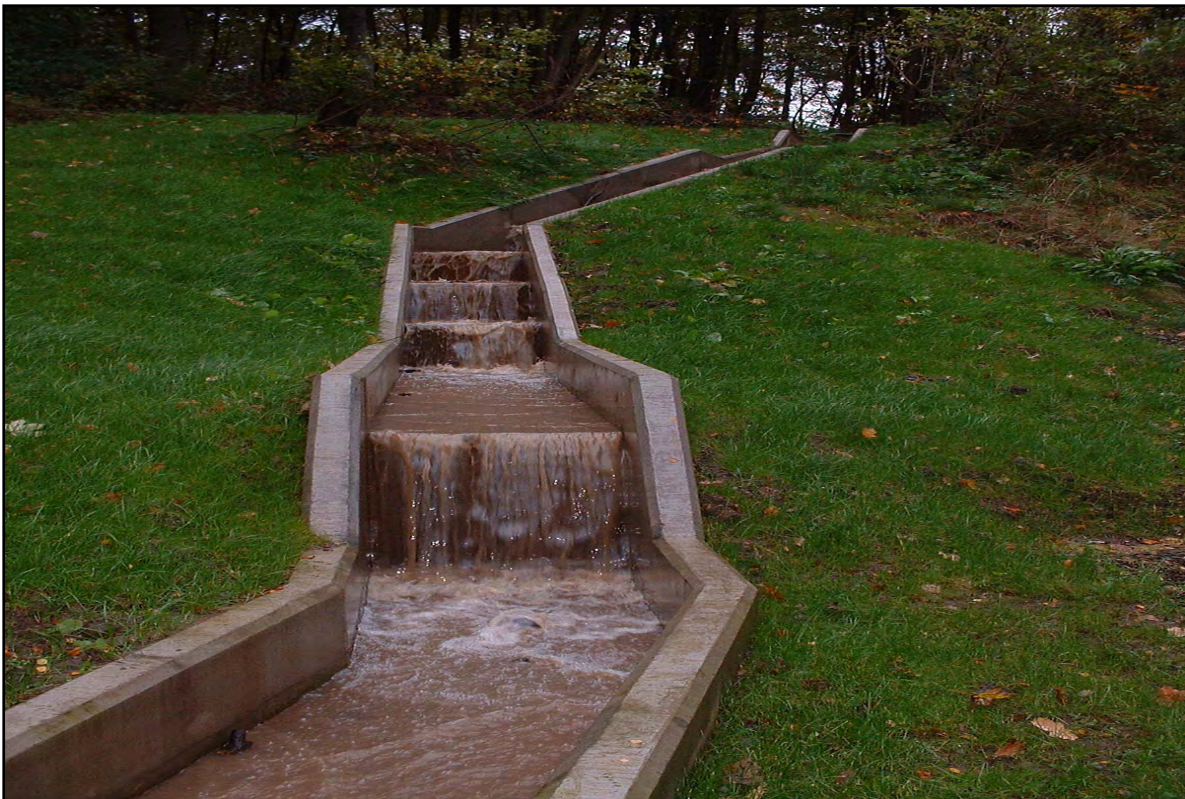
The Council intervened on several occasions (emergency basis as a result of calls from residents of Forrester Grove) to attempt to capture flood flows generated by this watercourse. Works had little effect because the drainage system receiving the watercourse did not have sufficient capacity to capture even limited flows.

Photo 10 – Part of New Watercourse Capture System at Inglewood, Alloa - 21/10/04

The Council determined that a permanent and sustainable solution was required to provide additional capacity and to redirect the burn waters back to its original outlet in Inglewood Pond to the south. This was confirmed by a hydrological study. This study recommended appropriate works to reinstate the capacity of the watercourse and to re-direct it to its original outfall in Inglewood Pond. It was also recognised that excessive silting problems seem to affect water quality in the Inglewood Pond and it was suspected that this might be because the pond was no longer receiving regular flushing out from the diverted watercourse. The issue was assessed in detail by consultant hydrologists and following detailed discussions with all adjacent landowners and affected householders, a solution was proposed, designed and a contract let to install a diverting drainage system. This system generally consists of an open concrete channel to capture flood flows in the existing watercourse, a section of piped watercourse to capture and permanently divert flows away from houses and pass the flows through adjacent developed land (the Forrester Lodge Business Complex) and then to a re-formed open grassed and planted channel to take flows to the Inglewood Pond. The grassed channel is shaped and lined to attenuate flows to minimise the impact on Fairy Burn (outlet of Inglewood Pond). The new system has been in operation since July 2004 and no further incidences of flooding have been reported since that time.

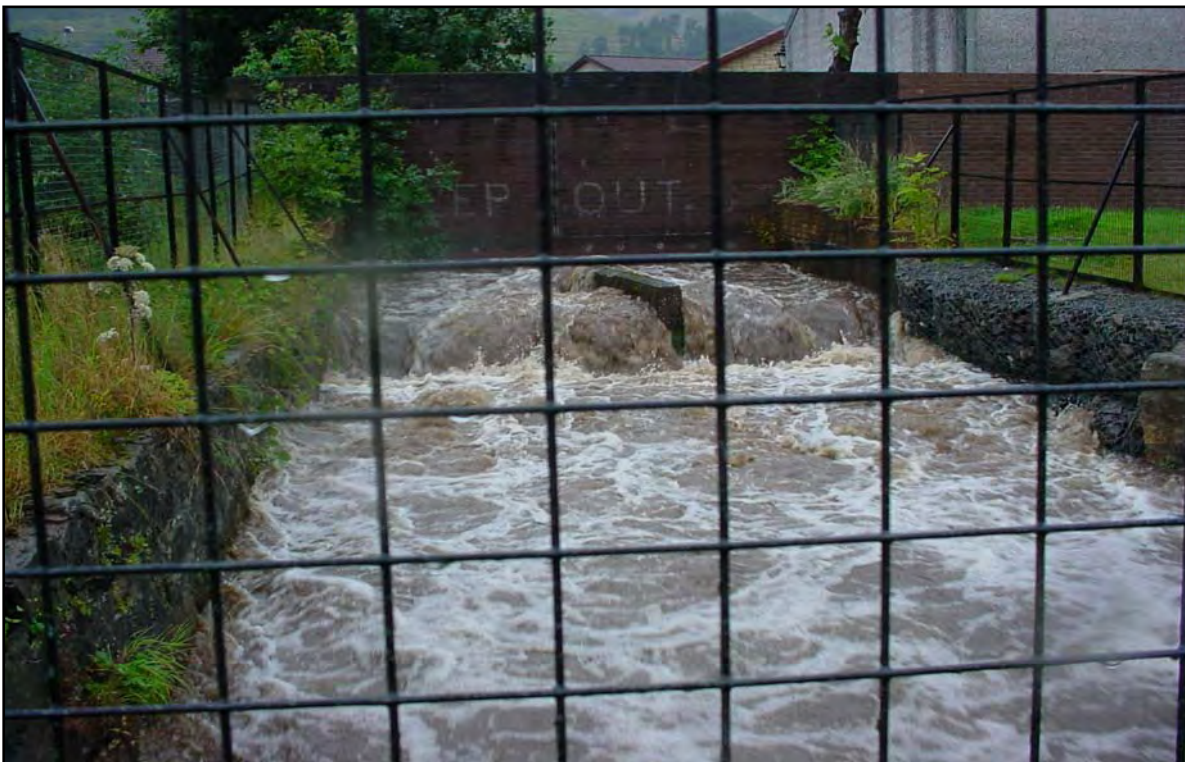
09/08/04 Alva Burn overtopped and flooded the school playground. No flooding to school building. Watercourse ref. B-07.

Photo 11 – Alva Burn looking north in Alva Primary School - 09/08/04

- At wall: debris grills removed.
- At footbridge: no works to date.

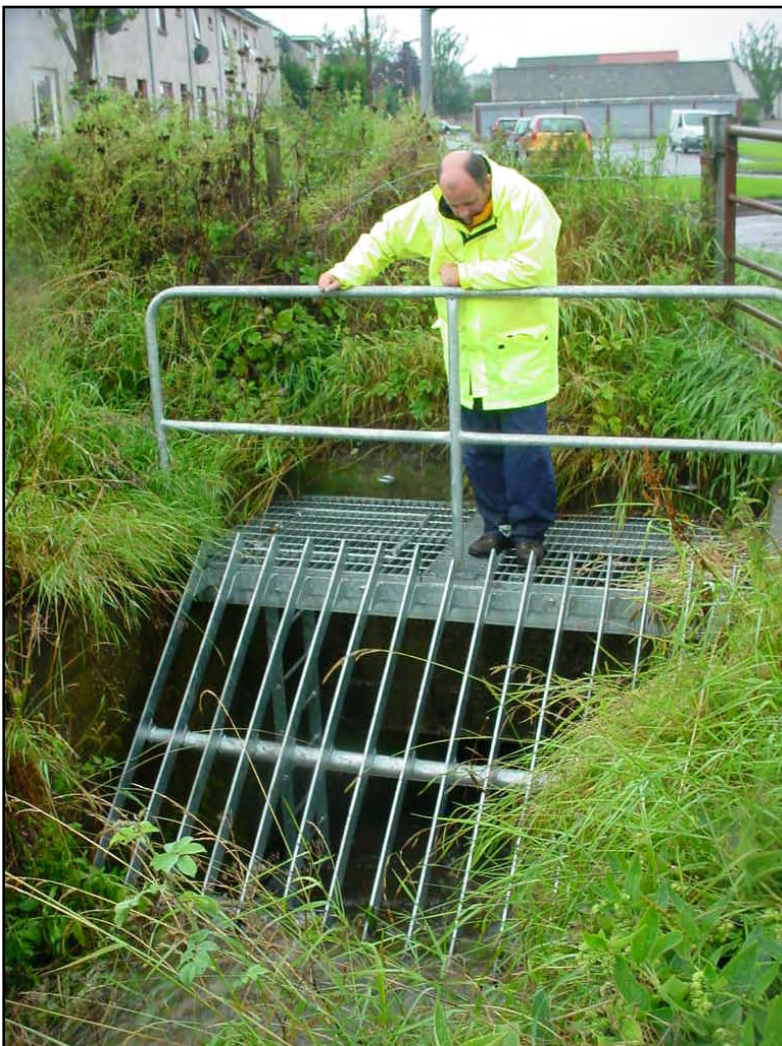
Photo 12 - New Trash Screen at Sauchie Burn Culvert - 10/08/04

- Council and landowner worked together to construct an earth bund in the field to direct overland flow into the burn channel. Council replaced the trash screen with a new trash screen and access platform, including ladder access to culvert (photo 12).
- No action.
