**REPORT FOR -  
ST BERNADETTE'S ROMAN  
CATHOLIC PRIMARY  
SCHOOL**

Document Ref. No : 13401 St Bernadettes Primary School ExeSum R1.0

# REPORT FOR –

## ST BERNADETTE'S ROMAN CATHOLIC PRIMARY SCHOOL

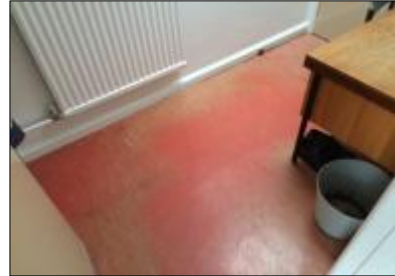
- Dated vinyl flooring installations to kitchen preparation office area.

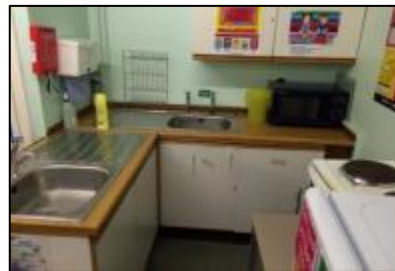
- Dated fixed furniture installation identified for lifecycle replacement.

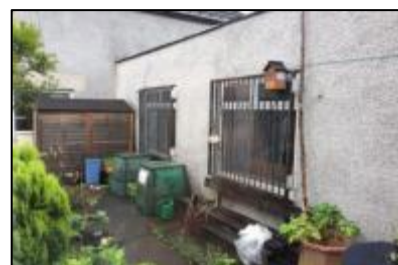
- Aged window bars to courtyard area identified for replacement.

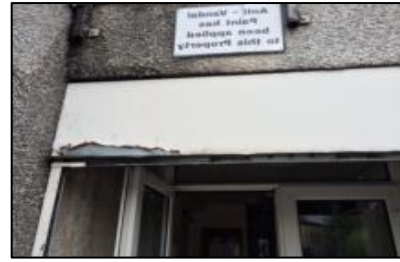
- Flaking decorations to external metalwork detailing.

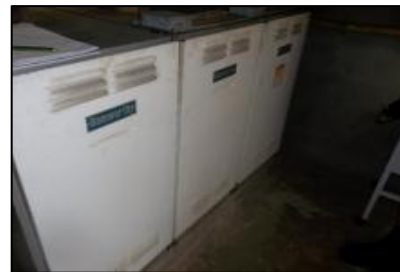
- 3 Hamworthy LTHW (Low Temperature Hot Water) Boilers in maintained condition but need replacement. At the time of the survey a boiler had been taken of duty for urgent repair.

3 Hamworthy LTHW Boilers are maintained but need replacement. At the time of the survey one boiler was taken out of service for repair. 1 ACV Heat Mast DHW gas fired water heater circa 1999 and remains in satisfactory condition. Grundfos heating pumps in good condition. The heating distribution system and emitters/steel radiators (with TRVs) used in classrooms/corridors, offices and other areas. Hot and cold water services are generally original but satisfactory, with some upgrades associated with replacement sanitary and kitchen facilities. Kitchen extract ventilation equipment is all in good condition along with toilet extracts.

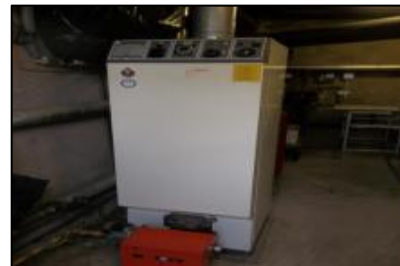
- 1 ACV Heat Master supplies DHW (Domestic Hot Water) in good condition circa 1999. LTHW Pressurisation unit and Expansion vessel. Grundfos heating pumps in good condition.
