**REPORT FOR -  
Abercromby  
Primary School  
Condition Survey**

Customer Name : Clackmannanshire Council

Project No : 13341

Document Ref. No : 13341/AbercrombyPS/Rev1.2/Draft

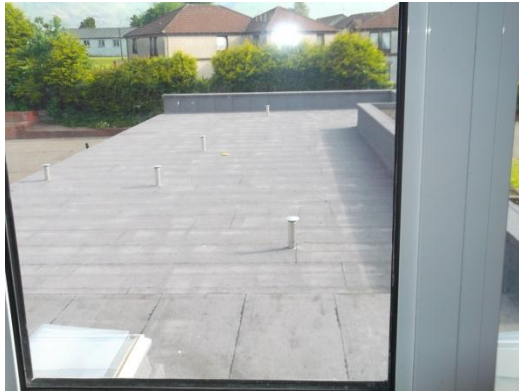
Flat roof to single storey section of main building and extension appear to have been recently replaced and show no apparent defects.

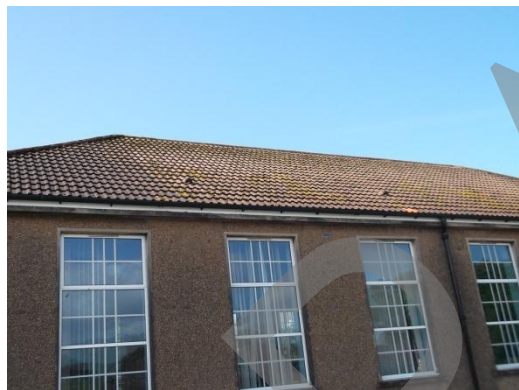
Pitched roof to assembly hall and gymnasium are generally in a good state of repair. Minor decay noted to tiles in conjunction with occasional slipped tiles and vegetation growth.

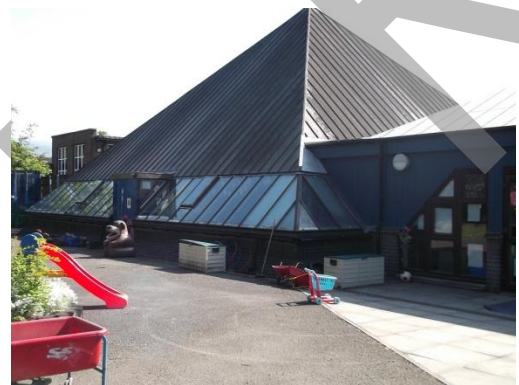
Pyramid style pitched roof to nursery shows signs of wear and tear with loose profiled joints. Internal moisture damage noted to ceiling suggesting roof leaks are common.

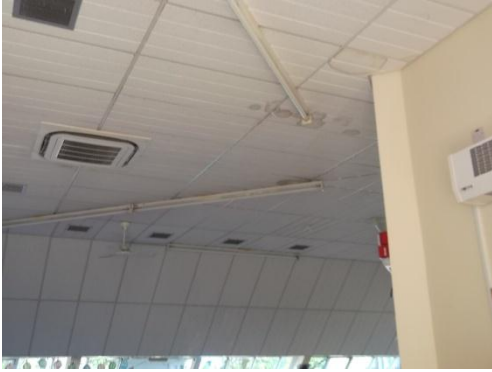
Suspended ceilings to nursery with evidence of moisture damage from possible roof leaks.

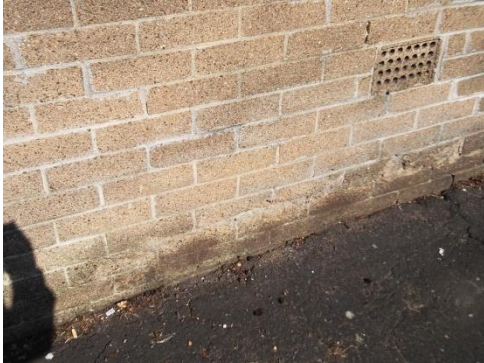
Early signs of decay to brickwork and mortar joints at low level to front and right hand elevations

Complete a scheme of wall repairs to main building structure and to perimeter dwarf walls and retaining walls across the site.

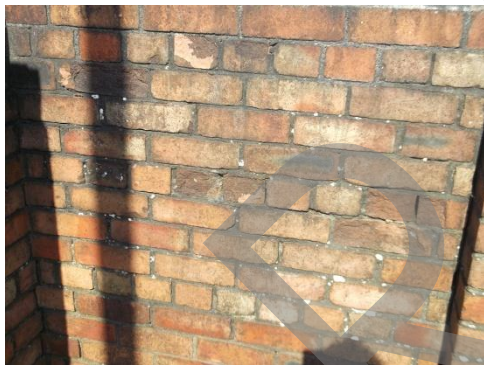
Typical example of decaying/cracked/damaged brickwork to perimeter and dwarf walls.

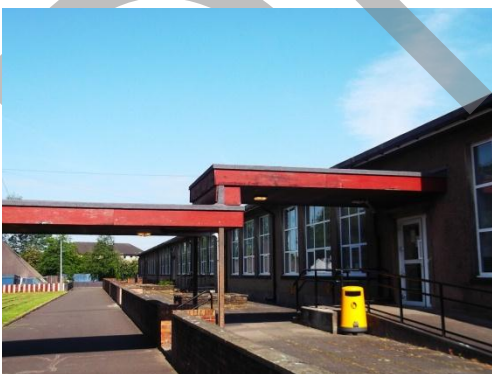
Deterioration to timber canopy linking main building to extension.

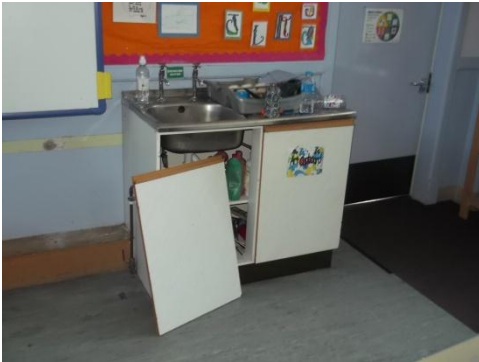
Typical example of dated fixed furniture installation to class room accommodation

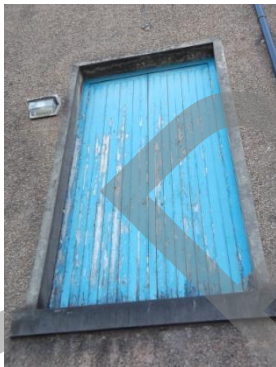
External decorations poor in places. Flaking paint to external timber detailing.

Complete a scheme of external redecoration to metalwork, gates, timber detailing, handrails and external doors to prevent future elemental decay and to improve physical appearance of the school.

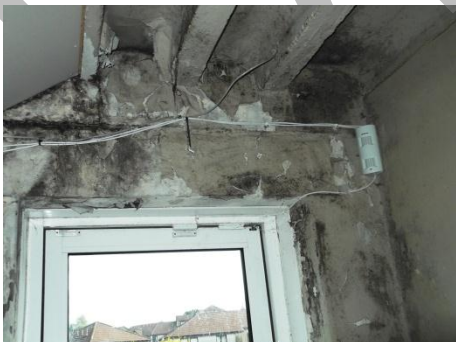
Wall finishes decayed to second floor store area above assembly hall. Wall finishes throughout school are generally in reasonable condition with minor impact damage.

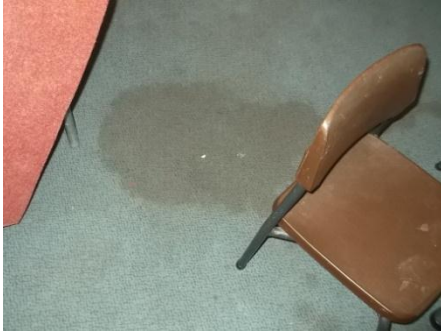
Isolated incidence of staining to carpet flooring finishes within nursery accommodation

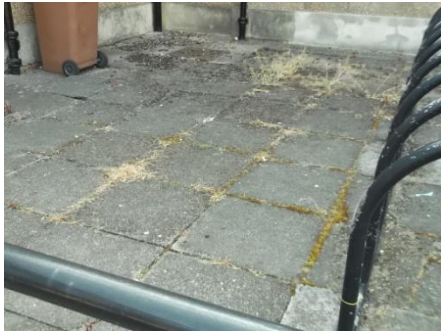
Typical example of loose and uneven paving surfaces with vegetation growth to joints.

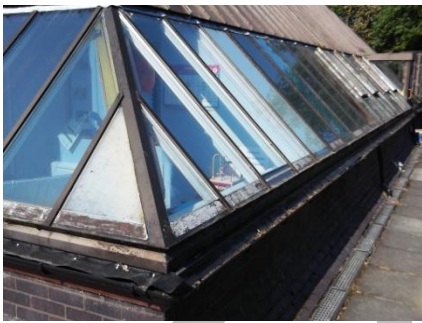
Dated glazing installation to nursery requiring lifecycle replacement.

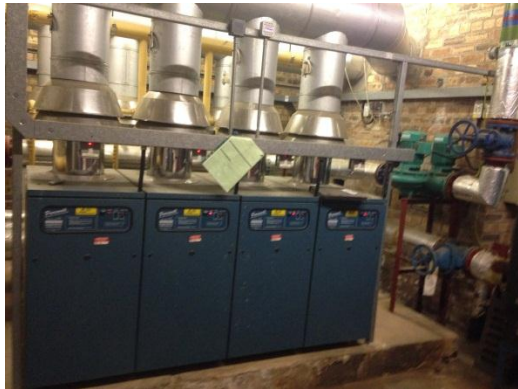
8 number modular, cast iron, atmospheric Gas-Fired Hamworthy Purewell, Automatic Ignition Boilers. Boilers were manufactured between 1993 and 2000; therefore the installed plant is between 14 and 21 years old. Visually, the condition is satisfactory; however, it should be borne in mind that the boilers are not as energy efficient as more modern alternatives. Associated pump sets and hand wheel gate valves are also showing signs of ageing. It is recommended good practice in all heating installations to use some form of water treatment to reduce formation of lime scale and black iron oxide sludge. No regime seems to indicate that systems have been chemically dosed.

Main boiler plant, associated components and pipework within the basement boiler house is of an age commensurate with the building and although plant has been well maintained, it is not fully efficient in comparison to modern alternatives and is reaching the end of its natural life. Investment would be required to bring it to a better standard.

1. Based on a detailed survey we would recommend plant room is reconfigured and all heating pipework be replaced with two pipe system;
2. Replace existing modular boilers with high efficiency condensing models. Ensure that dosing pot and pressurisation unit are installed;

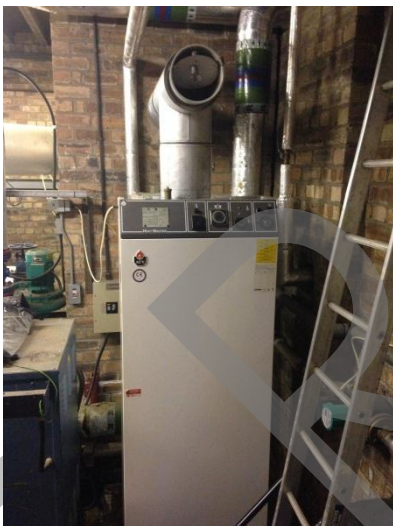
ACV Heatmaster is a direct gas fired hot water storage heater utilised to provide the domestic hot water demands of the school. The heater is in satisfactory condition. Approximate year of manufacture is 2001.

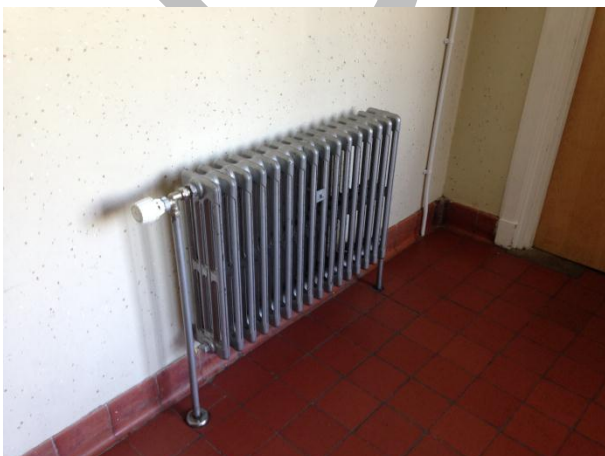
Existing cast iron radiators as fitted in classrooms and the gymnasium visually seem to be in good condition. However, it should be borne in mind that without chemical dosing of the water to the heating circuits the potential for corrosion and/or sludge build-up could significantly reduce the efficiency of these devices. The radiators have been fitted with thermostatic valves (TRVs). It is not known at this stage if the TRVs have been locked down to provide tamper resistance. It was noted during the survey that the heating pipework distribution is a one pipe system which will result in the heat emitters

furthest away from the boiler plant will be starved of heat resulting in unreliable room temperatures. The main disadvantage of this system is that each radiator receives water that has been mixed with the cooled water from previous radiator.

The boiler plant serves the heating requirements of the school, however as the heating pipework distribution is of single pipe design, rather than more standard two pipe (flow and return), this has a consequential result of larger pumps and larger bore pipework being required. As a consequence of a single pipework distribution there are many areas of the school building that do not receive adequate heating.

3. Replace existing cast iron heat emitters with LST (low surface temperature) units, ensure that tamper proof valves fitted to all devices;
4. Replace low level emitters in gymnasium and low level heat pipes in changing rooms with high level LTHW radiant panels and high level heat pipes respectively;

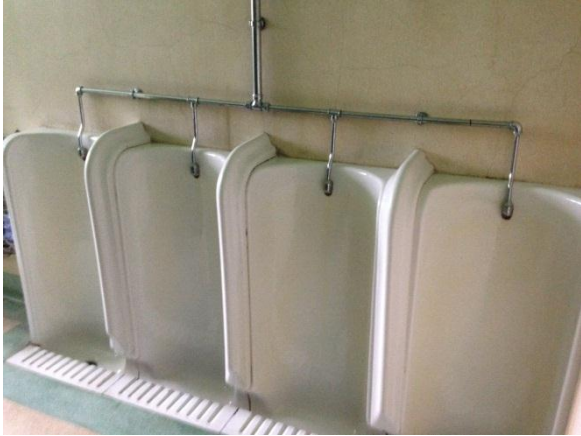
Much of the installed sanitary ware is of an age commensurate with the construction profile of the building. Whilst this is not a general problem within itself it does however date the installation. It is assumed that pipework serving sanitary appliances is of an age similar to the actual appliances. It may be that pipework modifications undertaken in the past may have resulted in dead legs and therefore the potential for legionellosis.

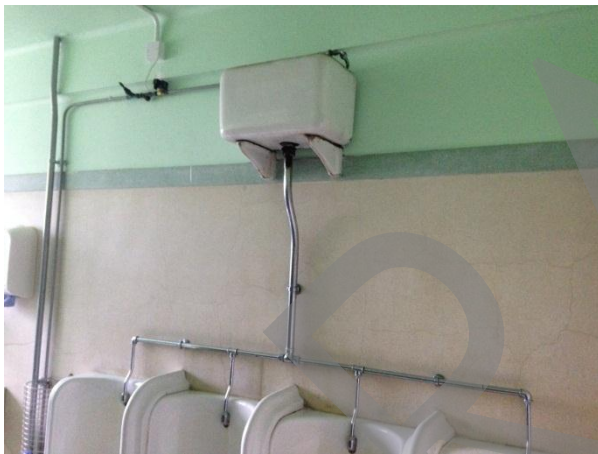
Cistern within boys' bathroom showing signs of deterioration due to age.

The boys' toilets near the main entrance are in a poor condition, the current sanitary ware is dated with the urinal cistern is showing some signs of deterioration due to wear and tear. The girls' toilets close to the cloakroom area have undergone refurbishment and are in satisfactory condition; however, this standard is not upheld throughout the school.

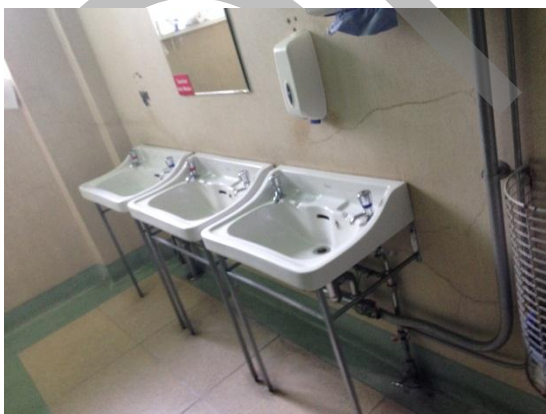
Wash hand basins within boys/girls bathrooms dated and associated pipework showing signs of light corrosion. On some wash hand basins there are no failsafe lockable blending valves fitted limited maximum temperature at the outlets to 43C.

6. Service and replace parts as necessary on existing boiler plant;
7. Ensure that all wash hand basins are fitted with temperature blending valve.

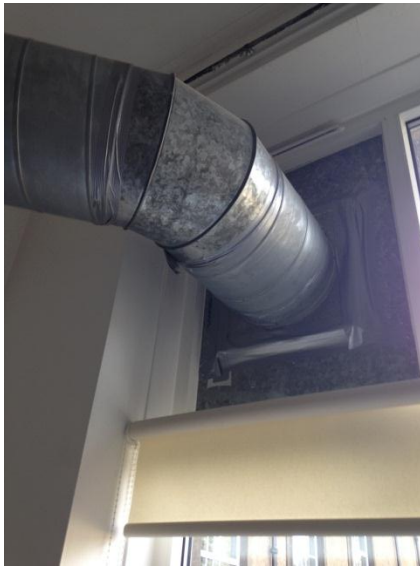
Kitchen canopy extract ductwork is poorly installed and duct joints/connections have been sealed using Duct tape. AS shown in the picture the duct discharges through a boarded up window. Under normal criteria the kitchen discharge would normally be at high level (above eaves height) to minimise potential of contamination and/or odours. Further investigation required into correct sizing of canopy, fire rated ductwork, gas safe interlock. Ductwork to be cleaned as per HVCA TR/19 Internal Cleanliness Ventilation Systems.

5. Modify existing kitchen extract canopy and associated ductwork. Ductwork discharge point to be relocated. Also ensure that gas safety interlock is fitted as standard;

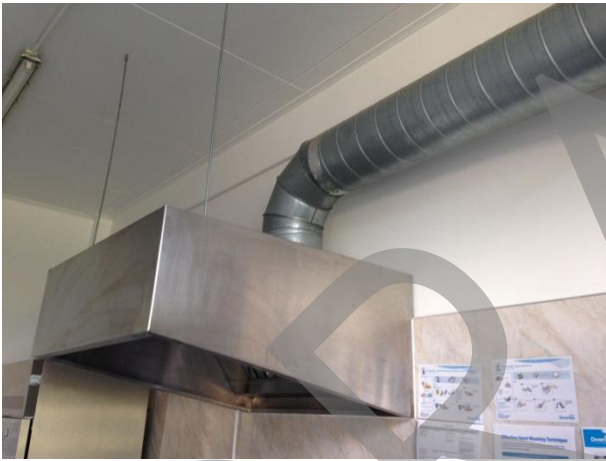
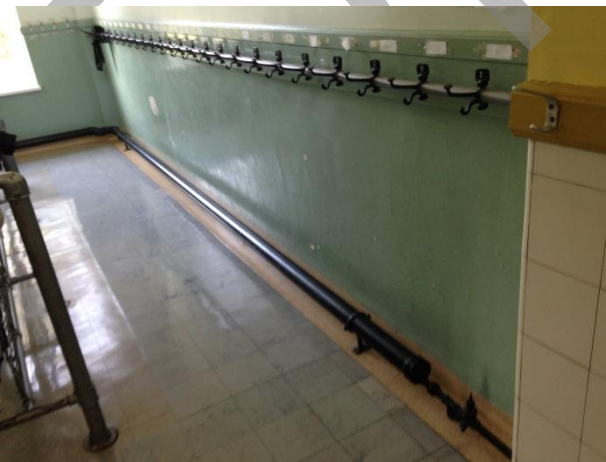
Low level pipe heating within cloakroom areas to provide background heat. Normal practice would be to provide wire mesh over pipes to prevent potential scalding (assuming flow and return temperatures of 80/72C) or re-route at high level.

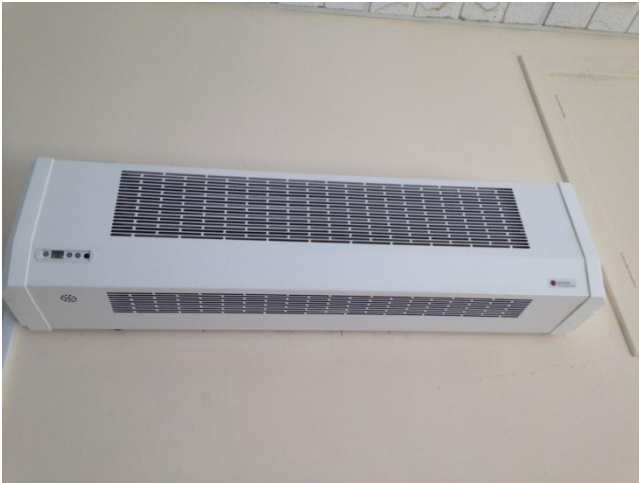
3 number Myson RC-25-18 Wall Mounted LTHW Fan Convecter within the extension are in good condition.

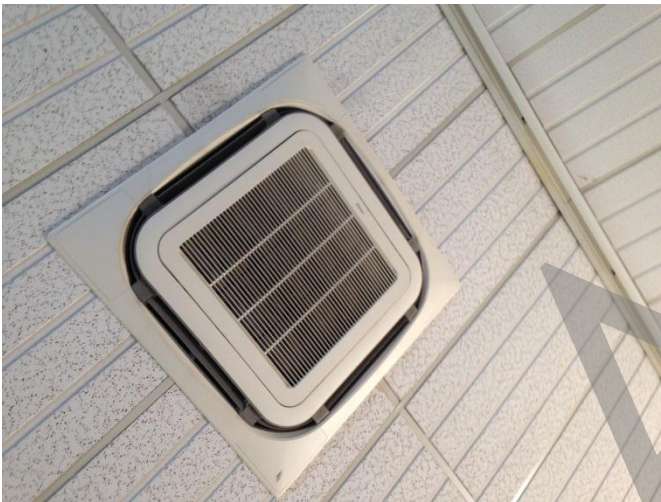
Daikin round flow ceiling mounted cassette installed within extension in satisfactory condition. There does not appear to be any interlink between LTHW fan convectors and the installed air condition which may result in the units competing against each other.

9. Check validity of air conditioning and LTHW systems within new extension.

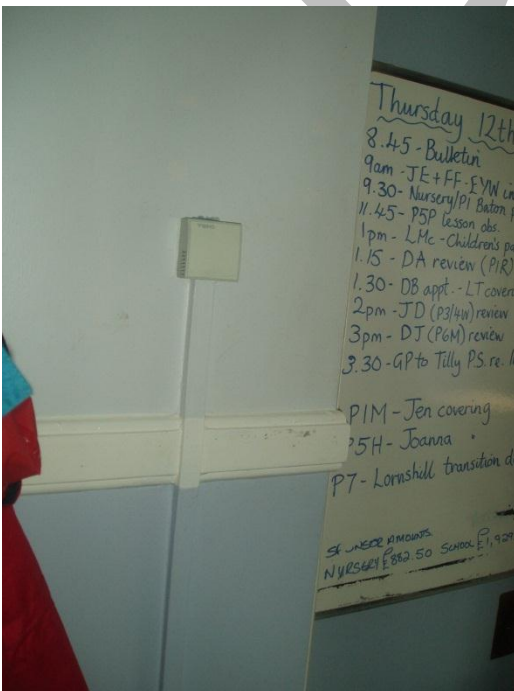
Two number temperature thermostat, one located in Staff Room, one located outside Assembly Hall.

Room temperature thermostats need a free flow of air to sense the temperature accurately; it is our opinion that the current location of the temperature thermostats is not conducive to even heat distribution throughout the school.

1. Replace and reposition temperature sensors;
2. Replace cast iron low level radiators to Assembly Hall;
3. Clean and flush existing pipework distribution system;
4. Install new extract fan to cleaners store;
5. Install new toilet extract ventilation system to toilets;

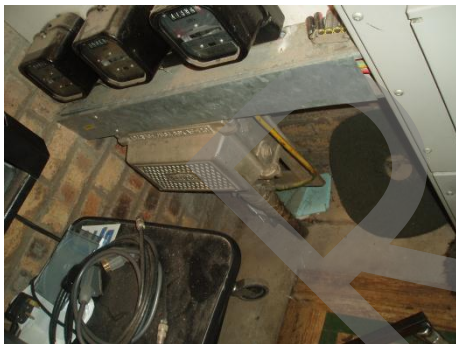
Main incoming PILC cable, cutout and metering.

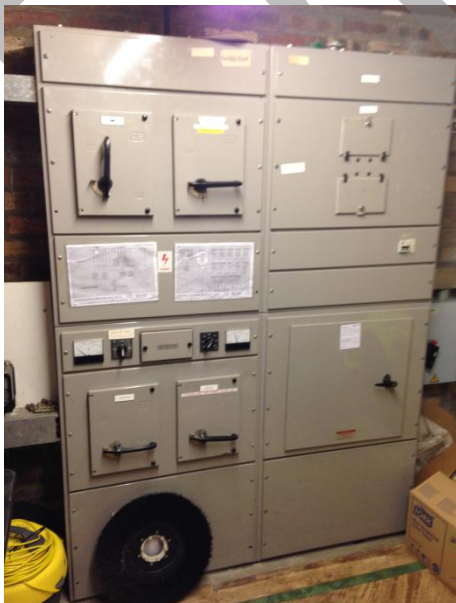
Main incoming panel board is tested and valid until 2015, the age is over 30 years old and has exceeded the recommended useful life.

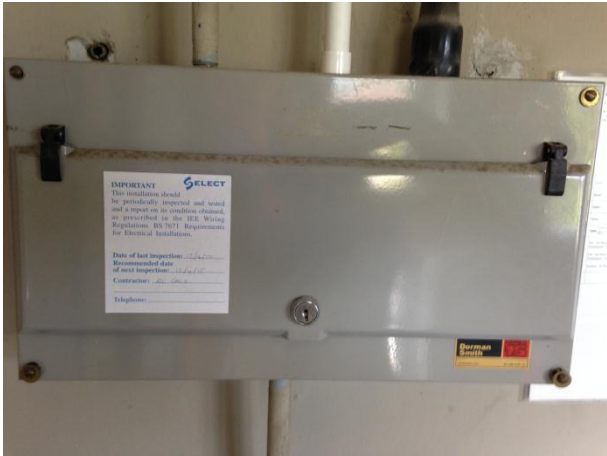
Distribution board was tested and valid until 2015, however the age of the DB has exceeded 30 years and is over the useful life recommended by electrical institutions.

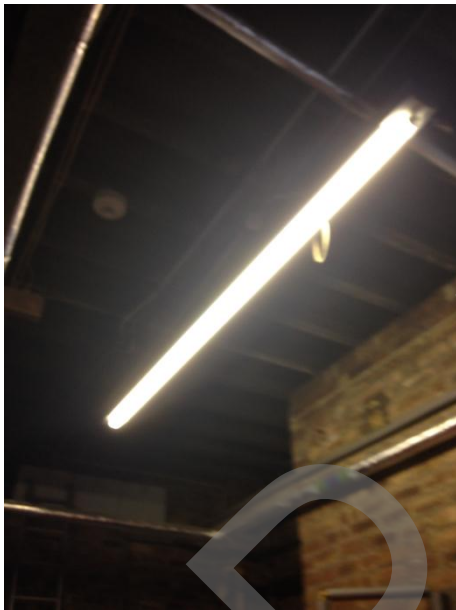
Boiler house old T8 fluorescent fittings

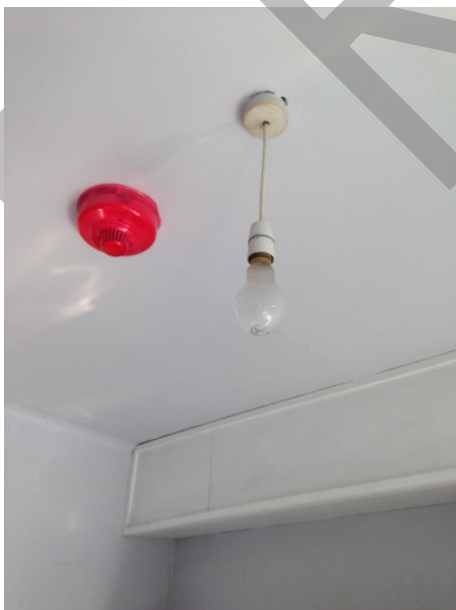
Light bulb shall be replaced with energy saving lamp

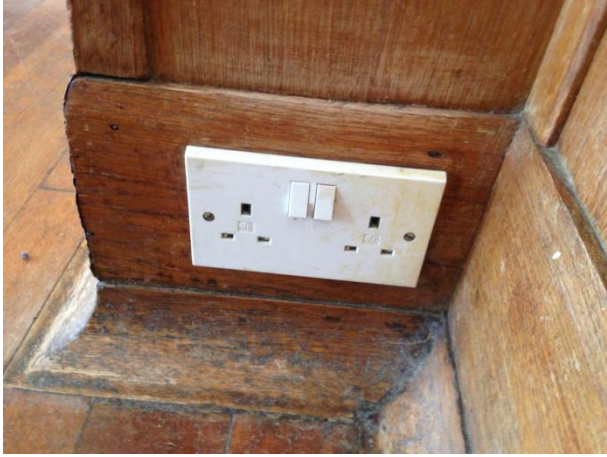
Socket within the wooden skirting

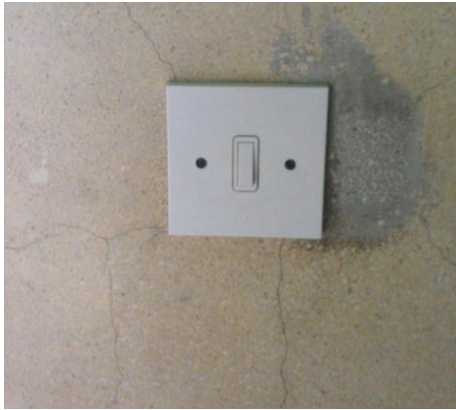
Old lighting switch
