CLACKMANNANSHIRE COUNCIL

Measures Required to Prevent or Mitigate the Flooding of Land

BIENNIAL REPORT – November 2009

**THE FLOOD PREVENTION AND LAND DRAINAGE
(SCOTLAND) ACT 1997**

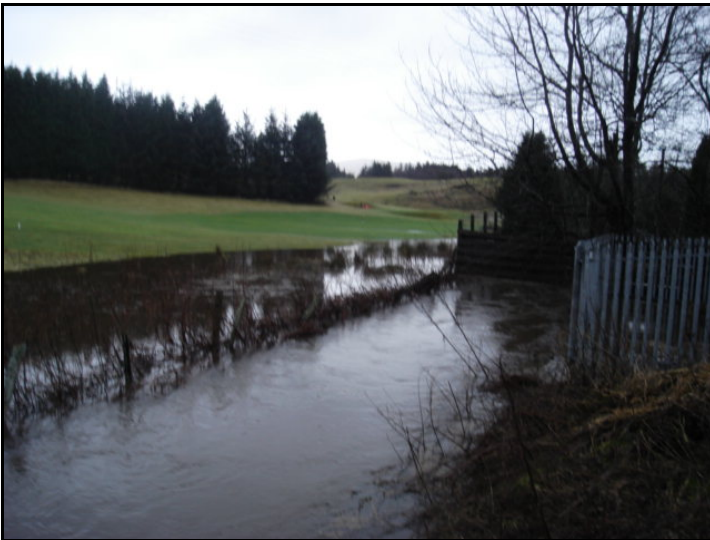
Out of Channel Flows at Back Burn, by Pool O'Muckhart - 25/01/08

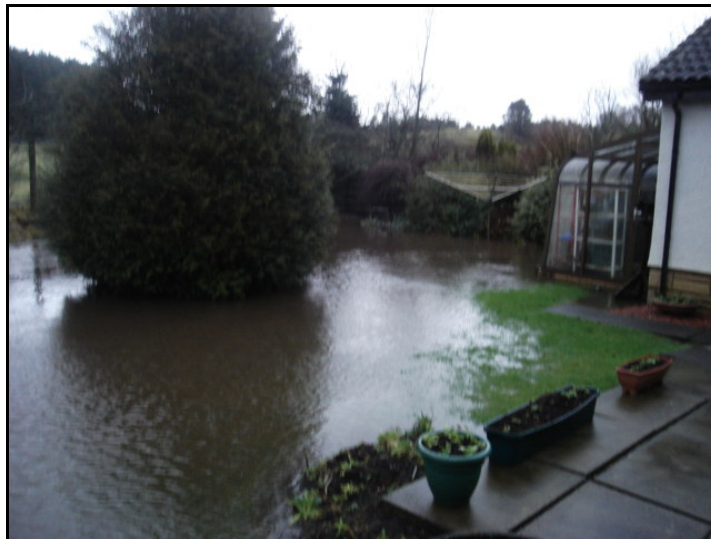
25/01/08 - A significant flood threat to house and safety, due to the depth of flooding noted, became apparent during a storm event. Debris became blocked at an wooden bridge used by local school pupils to access Muckhart Primary School to the north-west.

Flood Threat to house from debris blockage at Wooden Bridge adjacent Dollar Crook of Devon Road - 25/01/08

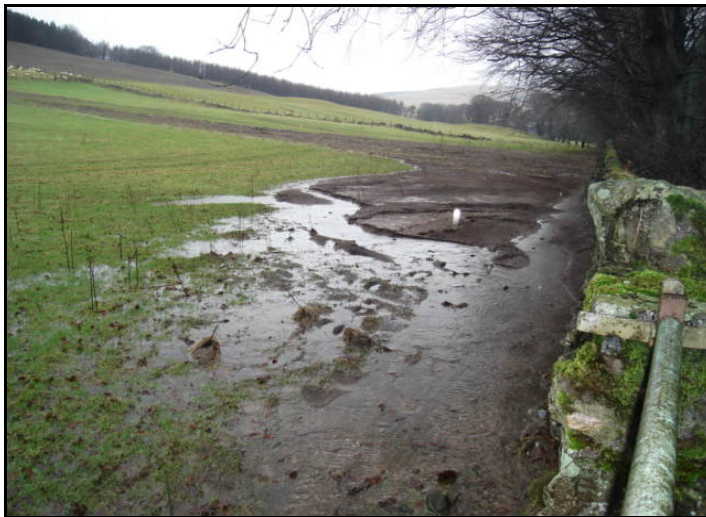
25-26/01/08 - Significant overland flows were generated on the southern slopes of Seamab Hill and on the A91 carriageway between Yetts of Muckhart and Pool O' Muckhart. These flows bypassed some properties and gathered to the rear of a stone boundary wall. The wall failed and debris and floodwaters then inundated a section of the A91 carriageway.

Flood flows and soils reach a boundary wall south of Geordie's Wood - 29/01/08

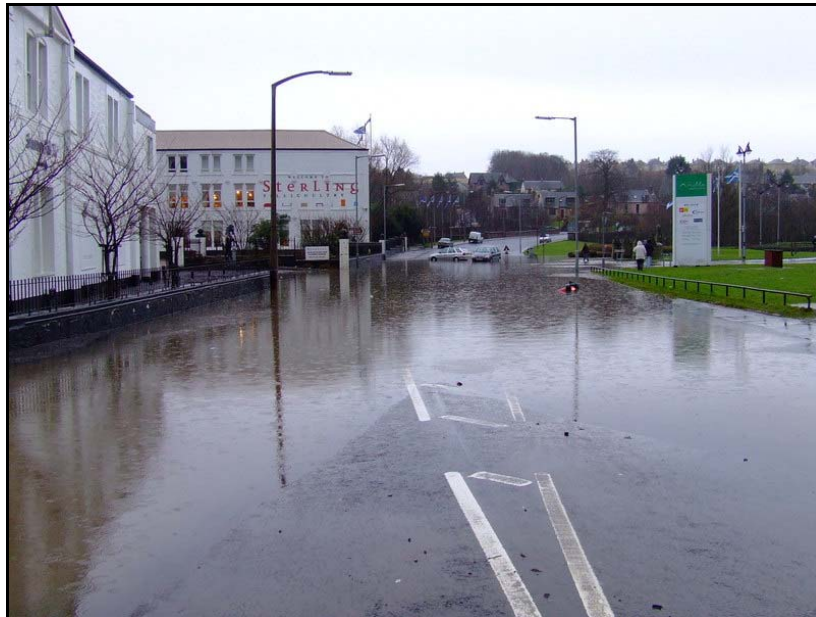
serious flooding occurred to Elistoun Drive, Kirkton Gardens, Glebe Crescent, Derby Place, Moss Road and the Sterling Furniture Store site, when the River Devon over topped the former railway embankment to the south of Elistoun Drive. The flooding also extended to Sterling Retail Village and Tillicoultry Bowling Club. This resulted in evacuation of residents and significant property damage. A threat to life was perceived for a time as the flooding at Elistoun Drive was said to be exceeding 1m in depth. 15 houses were flooded with some residents unable to fully return for 10 months. Flooding to Sterling Furniture Centre, Butterfly Inn, Devonvale Hall, Tillicoultry Bowling Club and Sterling Mills retail Village.

A908 Moss Road, Tillicoultry - 26/01/08

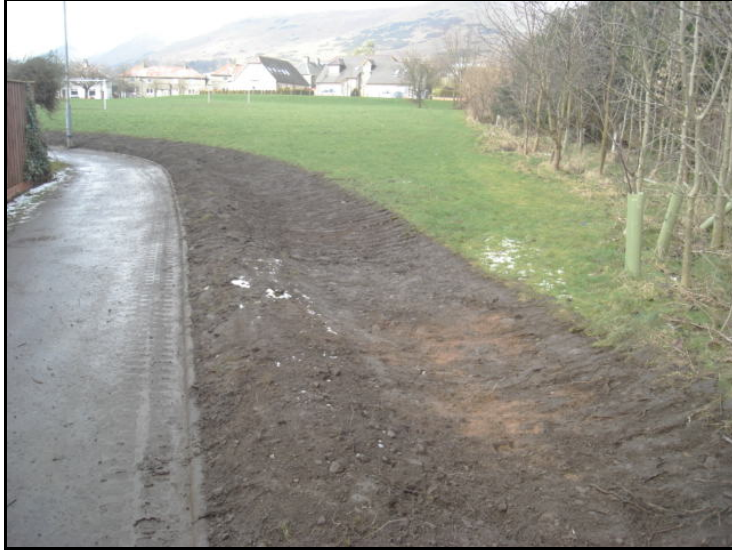
- DL-10 Drum Court (NS 966 982)**
Problem: Overland flow from new kick-about pitch.
Prevention / Mitigation Action: Works were completed March 2009 to form a collecting swale at the pitch's south end, directing collected flows to an open grated manhole in the swale. This manhole is connected to a pipe system which then directs flows to Kelly Burn.
Monitoring: Pass-by inspection.

Completed swale to capture flows at Drum Court, Dollar - 06/03/09

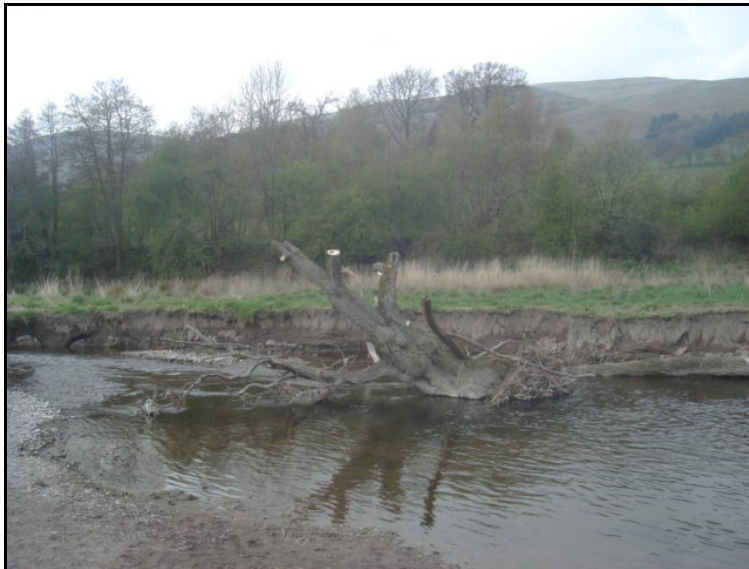
Tree debris within the River Devon, west of Dollar - 21/04/09

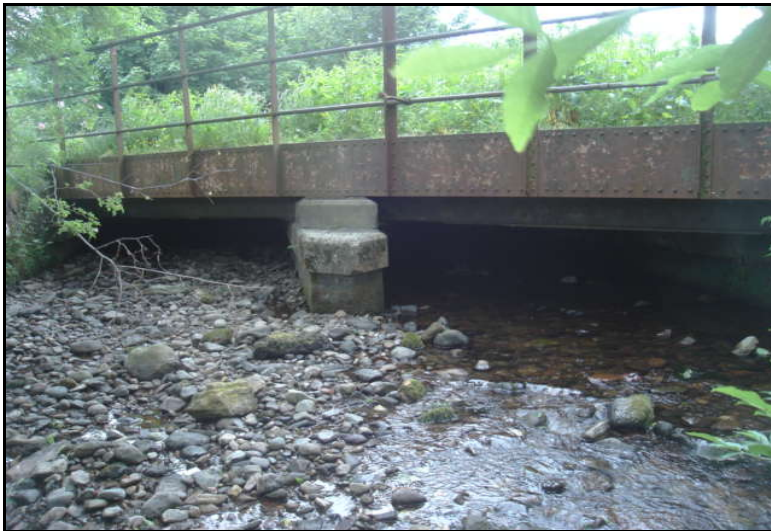
- Areas where excessive coarse sediment gathers may also create snagging points for vegetation and other debris creating dams and changing the flow line.

Build up of sediment beneath Mixed Leisure Route (Former Railway Bridge), Dollar Burn, Dollar - 22/06/09

As finer sediments are also of importance to biodiversity, where possible only coarse sediments will be removed from open watercourses and only where a clear flooding hazard would be alleviated. The dynamic nature of watercourses will ensure that finer sediments will move downstream naturally once the larger boulders have been removed. There will be locations where finer sediments gather in large quantities, e.g. weirs, bridge piers and on bends, and this will be removed if it appears to be retarding fine sediment movement, or if it might potentially lead to over topping, or significant capacity reduction. Coarse

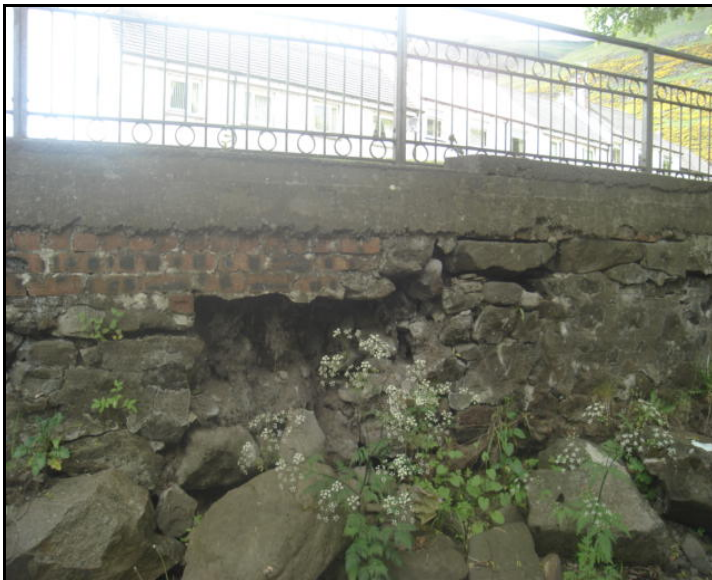
Damage to Retaining wall, Alva Burn, Alva - 28/05/09

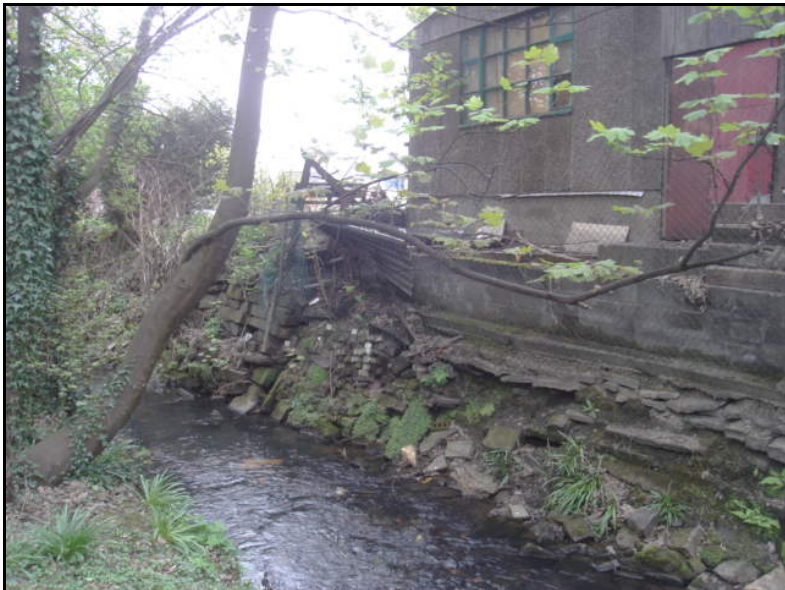
Failing Retaining structure adjacent to the Brothie Burn, Alloa - 15/04/09
