**REPORT FOR -
Tullibody Civic
Centre Condition
Survey**

Customer Name : Clackmannanshire Council
Project No : 13341
Document Ref. No : 13341/TullibodyCivic/rev1.2/Draft
Document held at NIFES : Glasgow

REPORT FOR – TULLIBODY CIVIC CENTRE

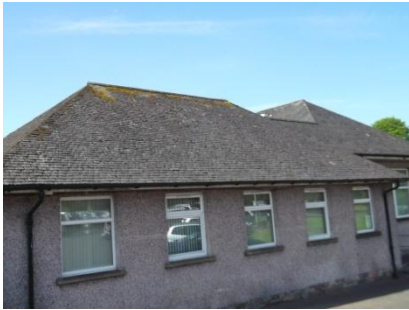
Slate roof coverings to pitched roof areas are deteriorating with incidences of slipped and damaged tiles. Vegetation growth noted to tiles

Replace dated pitched roof coverings to original building. Recommend that a full survey is completed to assess the roof structure prior to any roof covering replacement works are completed.

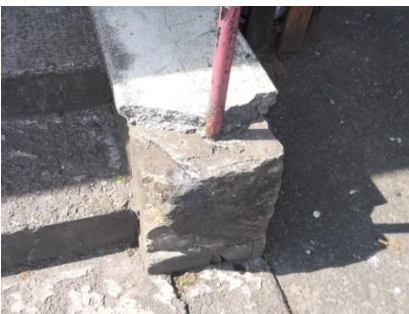
Cracked coping to steps to front entrance and concrete damage/decay

Carry out concrete repairs to finishes to external steps and hard standing areas.

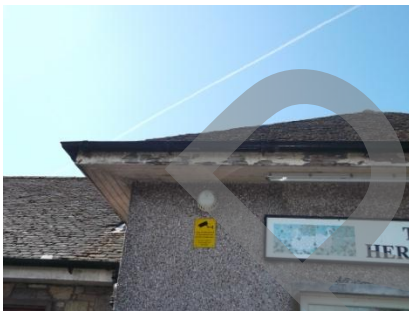
Typical example of external decoration to timber detailing. Rotting fascia's observed.

Complete a scheme of external redecoration to metalwork, timber detailing, handrails and external doors to prevent future elemental decay and to improve physical appearance of the building.

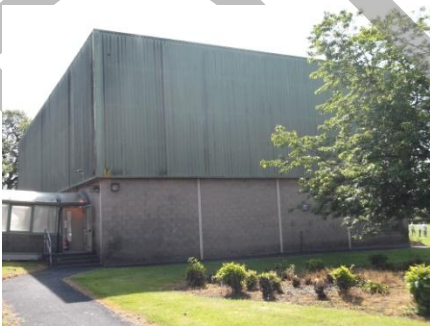
Cladding to games hall stained

Clean dirt/debris/mould to walls and cladding to games hall area to improve physical appearance and prevent possible future decay.

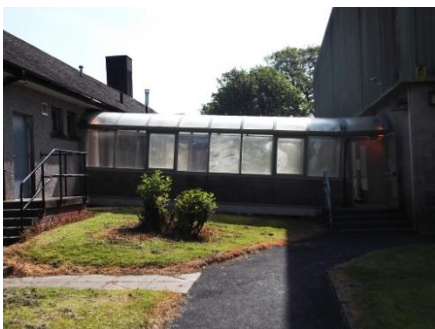
Link corridor from original building is showing signs of deterioration with blown and damaged glazing installations.

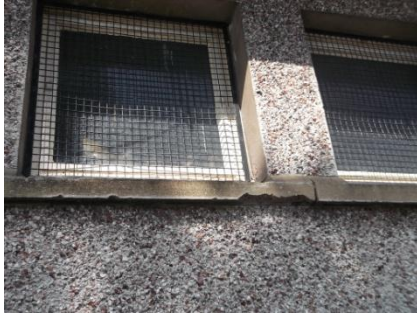
A scheme of window replacement has been completed. Partial single glazed windows still remain and in poor condition. Photo also depicts cracks and decay to concrete cills.

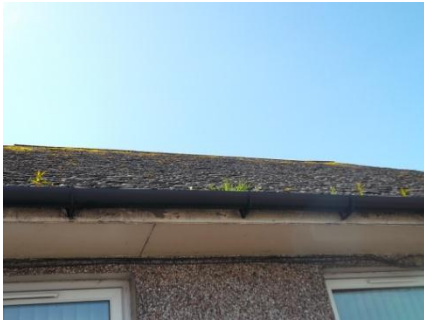
Vegetation to guttering systems.

Complete a scheme of overhaul, repair and replacement of defective guttering and downpipe systems. Vegetation growth observed in guttering systems, this may lead to future blockages and possible decay to surrounding elements as a result.

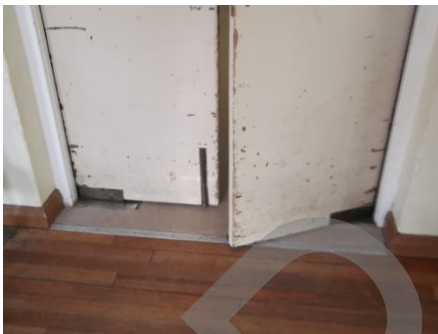
Internal doors are dated/damaged/worn to original building in non-refurbished areas.

Replace, repair and overhaul internal doors throughout original building. A majority of doors are in poor condition throughout and some which are labelled as fire doors appear inadequate with excessive perimeter gaps, signage provision and door closing devices.

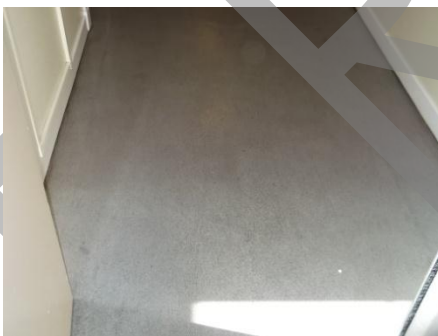
Typical example of dated vinyl sheet floor covering to communal areas in original building, link corridor and circulation space to games hall.

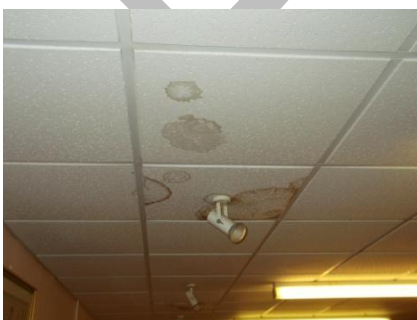
Water damage to suspended ceilings within first floor view area of games hall.

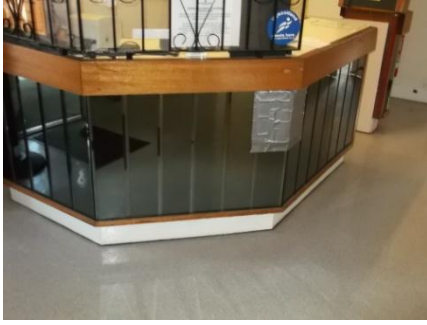
Dated reception counter at main entrance.

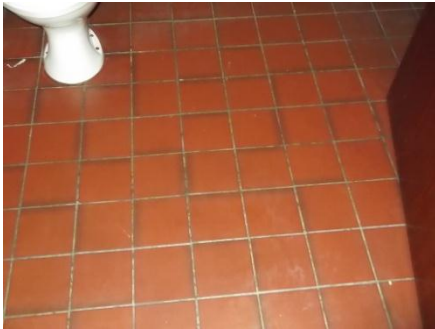
Typical example of dated ceramic tiled flooring to toilet accommodation and showers

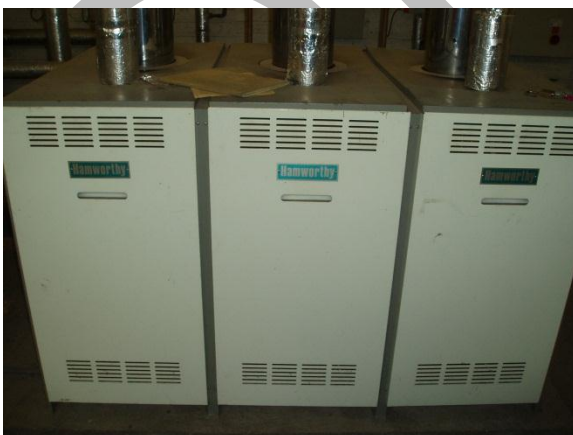
3No Hamworthy gas fired atmospheric boilers providing heating to the Civic Centre with the exception of the main sports hall. Boilers are between 14 to 25 years of age. No dosing pot, pressurisation unit installed. No tundish on boiler overflow.

Main boiler plant, associated components and pipework within the basement boiler house is of an age commensurate with the building and although plant has been well maintained, it is not fully efficient in comparison to modern alternatives and is reaching the end of its natural life. Investment would be required to bring it to a better standard.

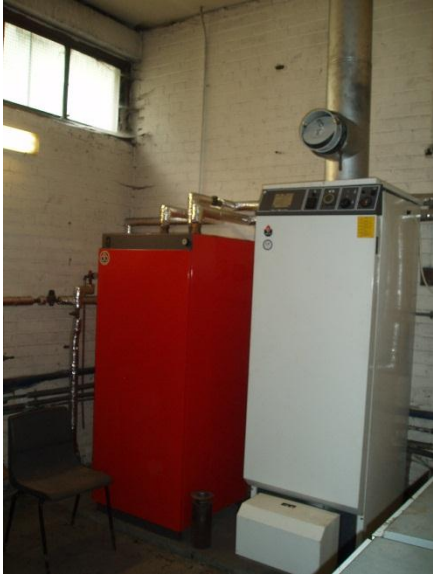
1No ACV Heatmaster gas fired hot water boiler linked to 1No ACV storage vessel.

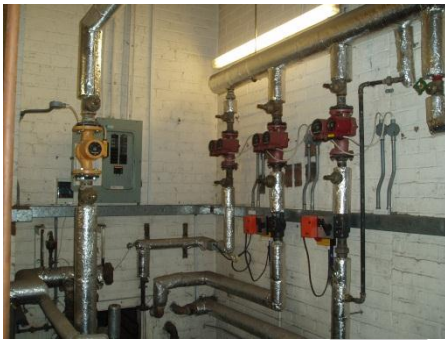
Plant room heating pipework is generally in good condition but requires some modernisation and replacement insulation.

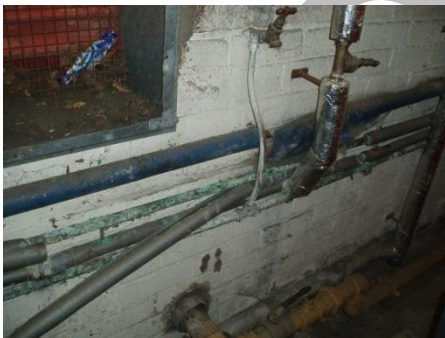
Cold water mains pipework in very poor condition showing signs of major corrosion and lacking sufficient insulation.

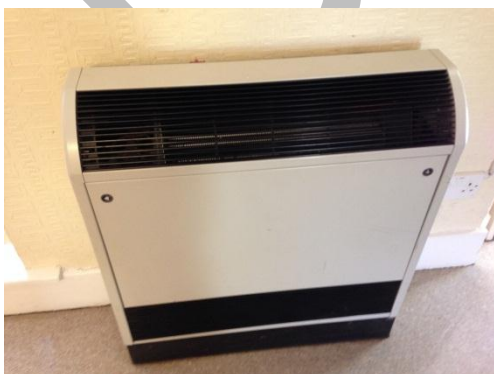
Dunham Bush LTHW fan convectors at Civic Centre entrance and in Function Suite. Units appear to be in good condition.

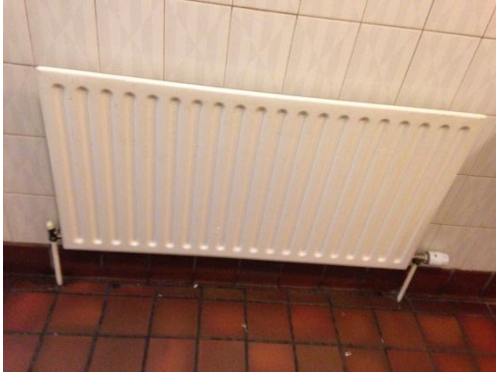
Typical pressed steel radiators as installed. The radiators are fitted with thermostatic radiator valves though it is not known if these are lockable to prevent potential tampering.

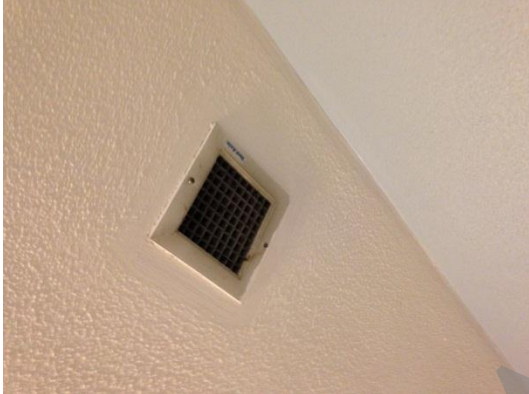
Egg-crate style toilet extract grilles fitted in sanitary accommodation. The grilles show build-up of thick dust, therefore it is assumed that this has penetrated into the ductwork serving the grilles, as such it would be highly recommended that a deep clean of grilles/ductwork etc be undertaken.

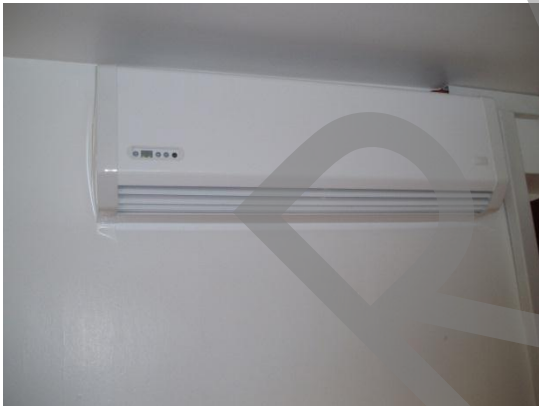
Myson wall mount AC unit installed in Kitchen adjoining the Function Suite. Unit is in good condition.

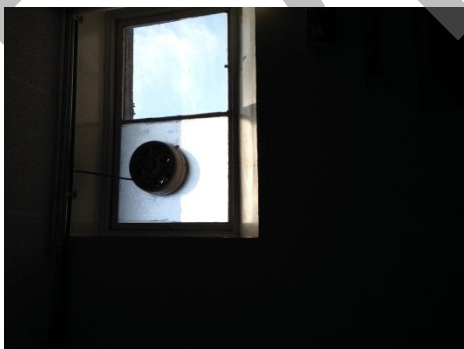
3No window fans within Function Suite are ageing and in need of an upgrade.

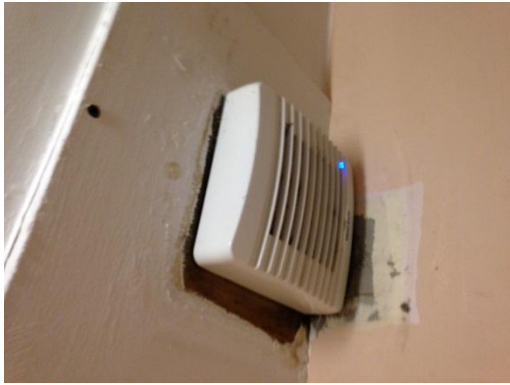
Disabled toilet Vent Axia extract fans in poor condition.

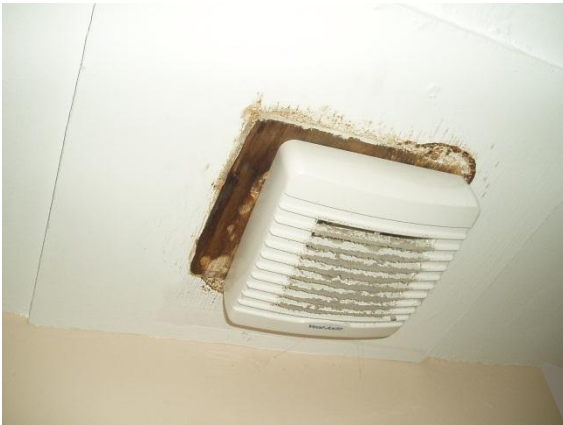
Vent Axia toilet extract fans in poor condition.

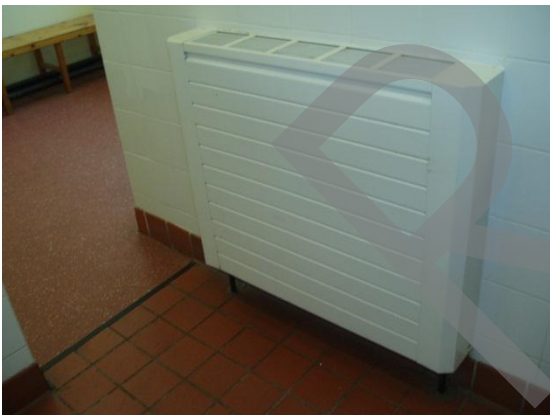
LST radiators installed in circulation areas are in good condition.

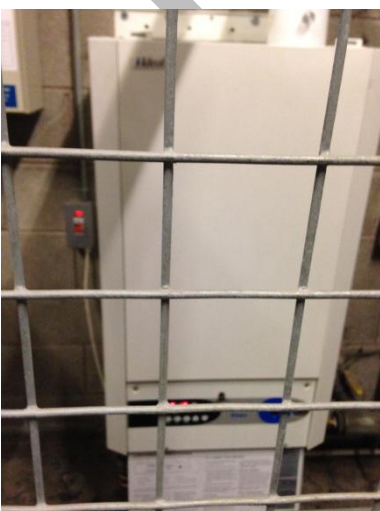
1 No Ideal Imax gas fired atmospheric boiler installed in Meeting Room overlooking Sports Hall. This boiler serves underfloor heating manifolds to Sports Hall and Meeting Room. Visually the unit is in good condition.

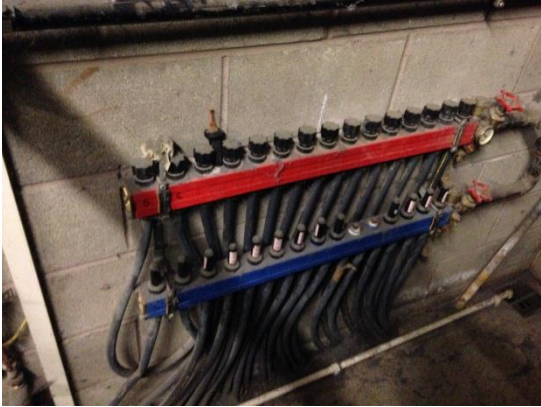
Underfloor heating manifold to Sports Hall

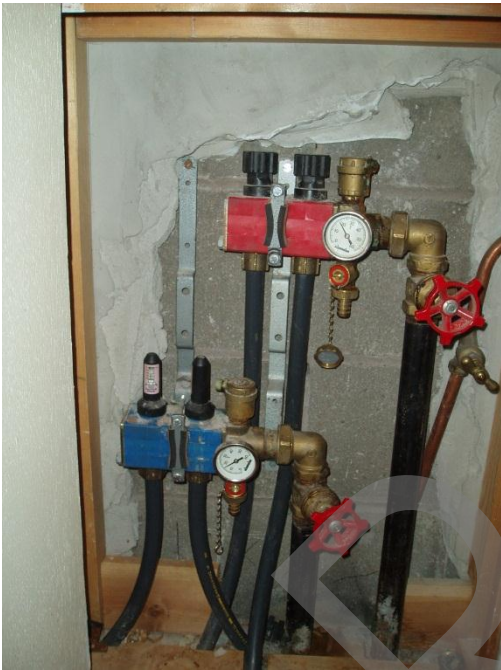
Underfloor heating manifold to Meeting Room

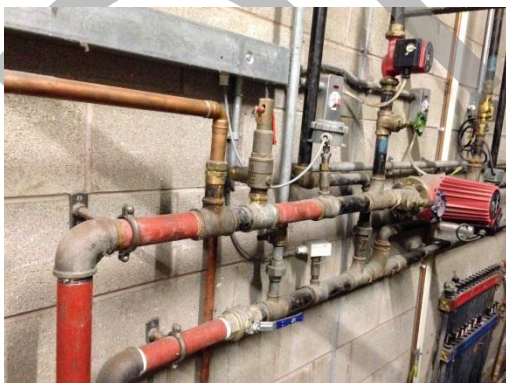
Pipework within Sports Hall storage room and requires insulation.

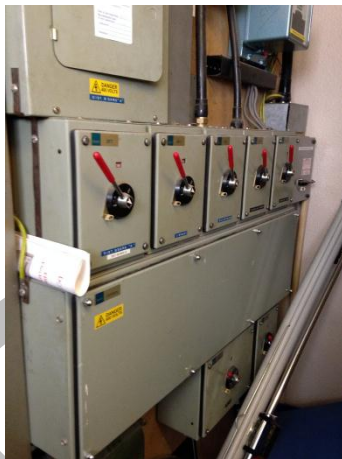
Main incoming switchgear was last tested in 2013 and is valid until 2018, the age is over 30 years old and exceeded the recommended useful life.

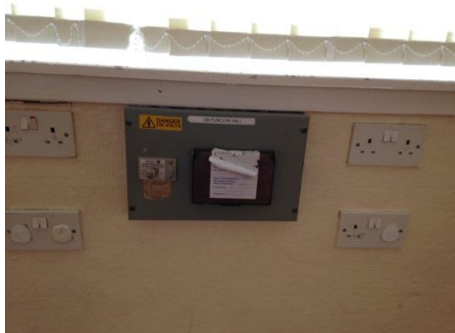
Distribution boards were tested and are valid until 2018; however the age of the DB's exceeded 30 years and past the useful life recommended by electrical institution.

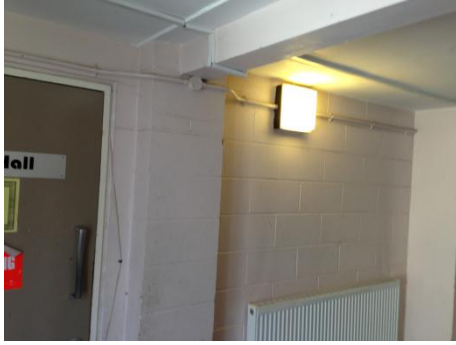
Old 2D luminaire

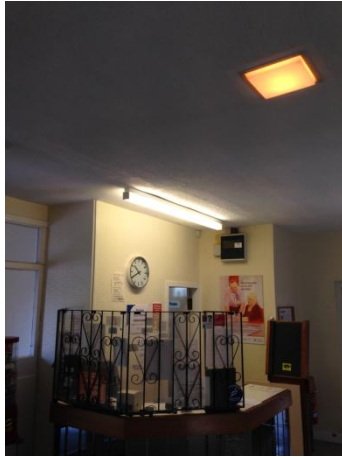
Discoloured luminaire near reception

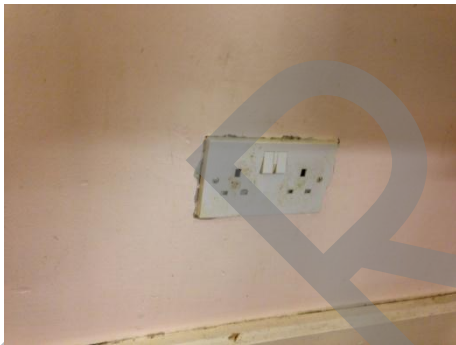
Socket is covered in dirt and ageing

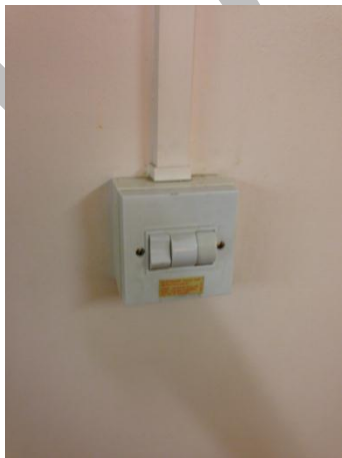
Old lighting switch

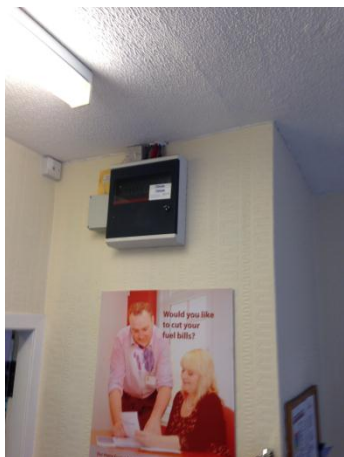
Repeater fire alarm panel position inappropriately at high level.
