REPORT FOR - Cochrane Hall

Customer Name : Clackmannanshire Council
Project No : 20229
Document Ref. No :
Document held at NIFES Sale

Cochrane Hall

1.0 Cochrane Hall

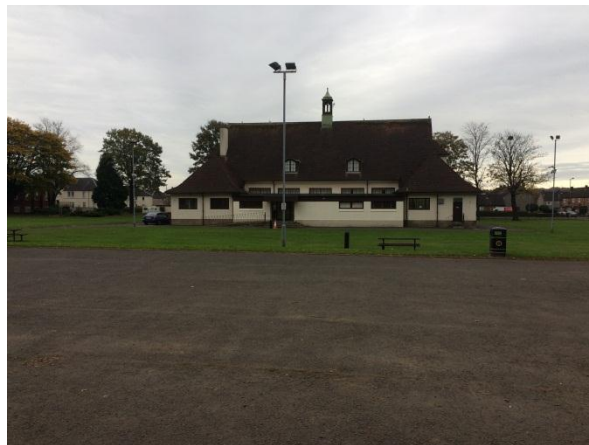
- Roadway adjacent to property showing pot holes and crazed wearing course.

The property noted to be in good order, although externally there is pot holes to the driveway.

Resurface adjacent pot holed road/drive.
