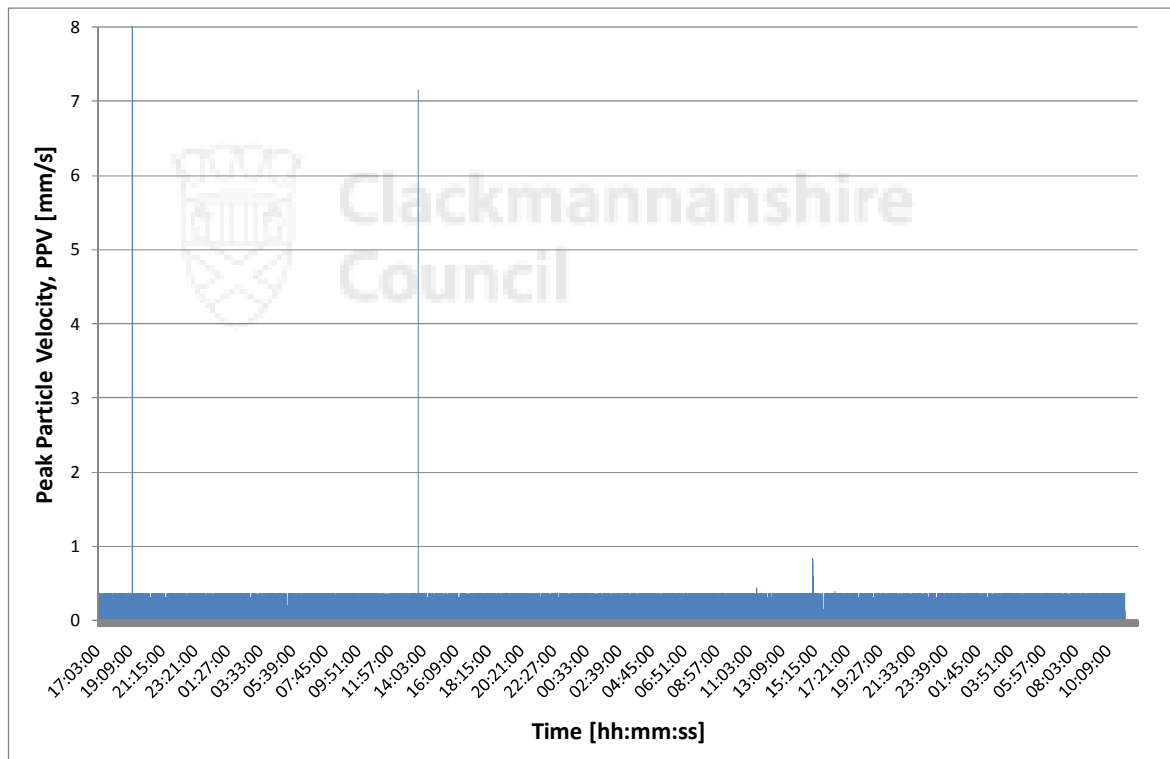
Figure 5.25: Time History of 30 second PPVs Measured at 27 St Serfs Grove, Clackmannan

5.52 Figure 5.25 shows the time history of the measured PPVs. The passage of trains would give rise to a series of regularly spaced peaks of roughly equal magnitude. Here, however, we see only three peaks of very variable magnitude. These are likely to be the result of events other than train pass-bys, such as disturbance by a resident, or a falling tree branch or similar. The latter is not unlikely given the strong winds early on.

- 5.53 The highest measured PPV was in excess of 8 mm/s. This value is irrelevant for the aforementioned reasons. It is reasonable to conclude that rail vibration levels did not exceed the noise floor of the instrument, which is at around 0.3 mm/s. As this value is well below the criteria, it is highly unlikely that any structural damage, including cosmetic, would result from this level.
