### Location 7: 75 Grange Road, Alloa

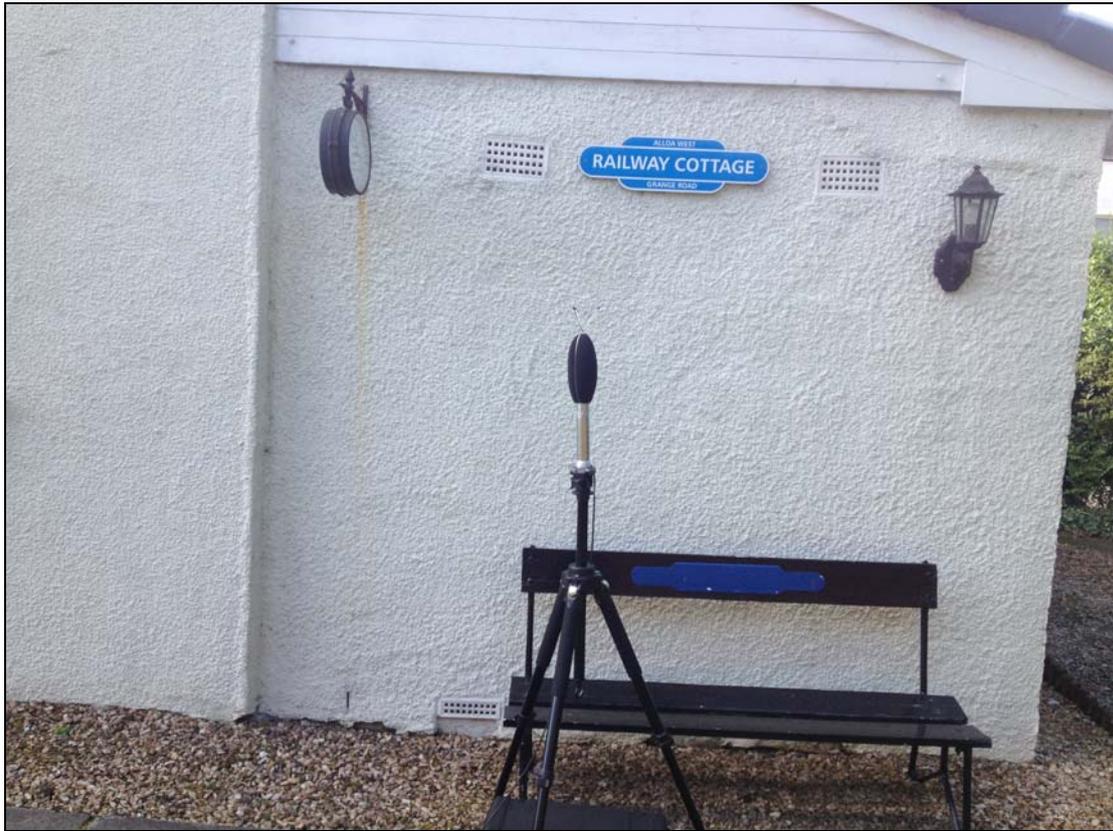
Photograph A.7: Measurement Location at 75 Grange Road

The measurement position was located 1m from the northern facing façade, within the rear garden area of the property. This position in turn was approximately 8m from edge of the railway line as shown in Figure A.7. The Rion NL-52/Brüel & Kjær 2250 sound level meter was secured within a weatherproof box with the microphone positioned 1.5m above the ground, see Photograph A.7. The noise monitoring equipment was calibrated both before and after each measurement period using an acoustic calibrator, which has itself been calibrated against a reference set traceable to National and International Standards. There was no shift greater than 0.2 dB in the observed calibration level. The sound level meter was secured at the property and left continuously logging throughout the measurement period.

The Brüel & Kjær 2250/2260 sound level meter was secured to a tripod with the microphone 1.5m above the ground, adjacent to the Rion NL-52/Brüel & Kjær 2250 sound level meter. The monitoring equipment was calibrated both before and after the measurement period using an acoustic calibrator, which has itself been calibrated against a reference set traceable to National and International Standards. There was no shift greater than 0.2 dB in the observed calibration level. Fifteen minute snapshot noise level measurements were undertaken with the Brüel & Kjær 2250 throughout the measurement procedure and are shown in Table A.7.

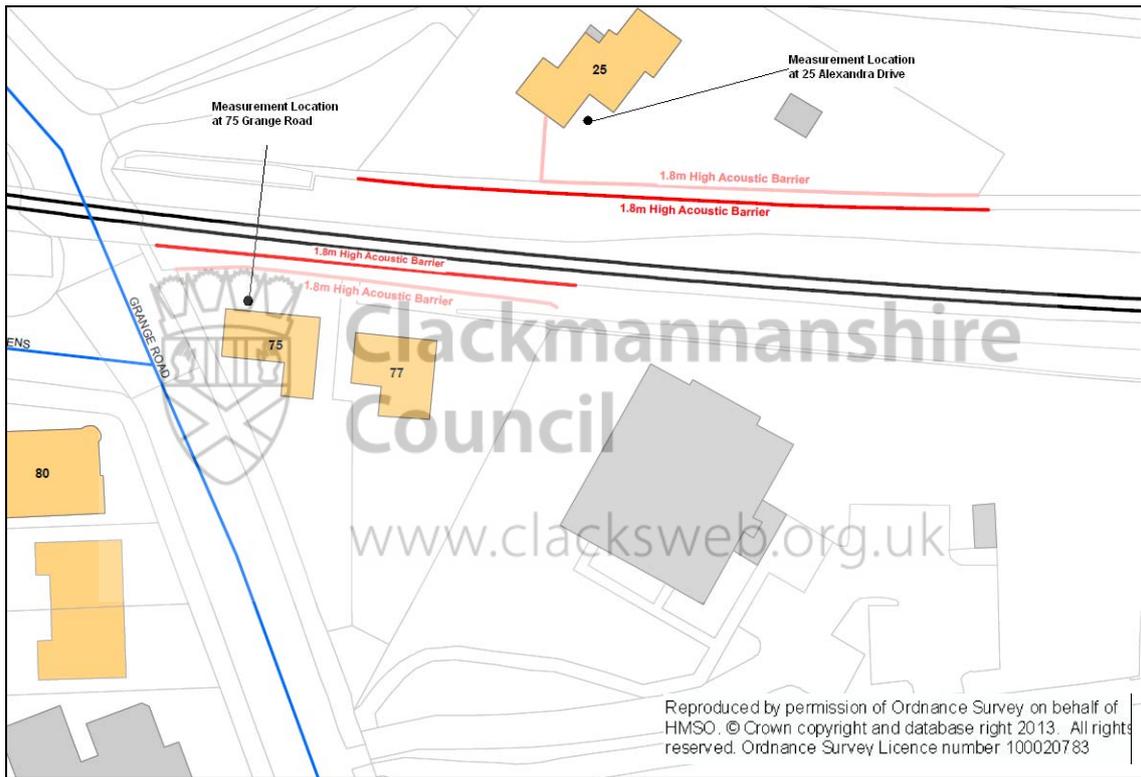
Figure A.8: Measurement Location at 25 Alexandra Drive

The measurement position was located 1m from the southern facing façade, within the rear garden area of the property. This position in turn was approximately 8m from edge of the railway line as shown in Figure A.8. The Rion NL-52 sound level meter was secured within a weatherproof box with the microphone positioned 1.5m above the ground. The noise monitoring equipment was calibrated both before and after the measurement period using an acoustic calibrator, which has itself been calibrated against a reference set traceable to National and International Standards. There was no shift greater than 0.2 dB in the observed calibration level. The sound level meter was secured at the property and left continuously logging throughout the measurement period.

The Brüel & Kjær 2250 sound level meter was secured to a tripod with the microphone 1.5m above the ground, adjacent to the Rion NL-52 sound level meter. The monitoring equipment was calibrated both before and after the measurement period using an acoustic calibrator, which has itself been calibrated against a reference set traceable to National and International Standards. There was no shift greater than 0.2 dB in the observed calibration level. Fifteen minute snapshot noise level measurements were undertaken with the Brüel & Kjær 2250 throughout the measurement procedure and are shown in Table A.8.

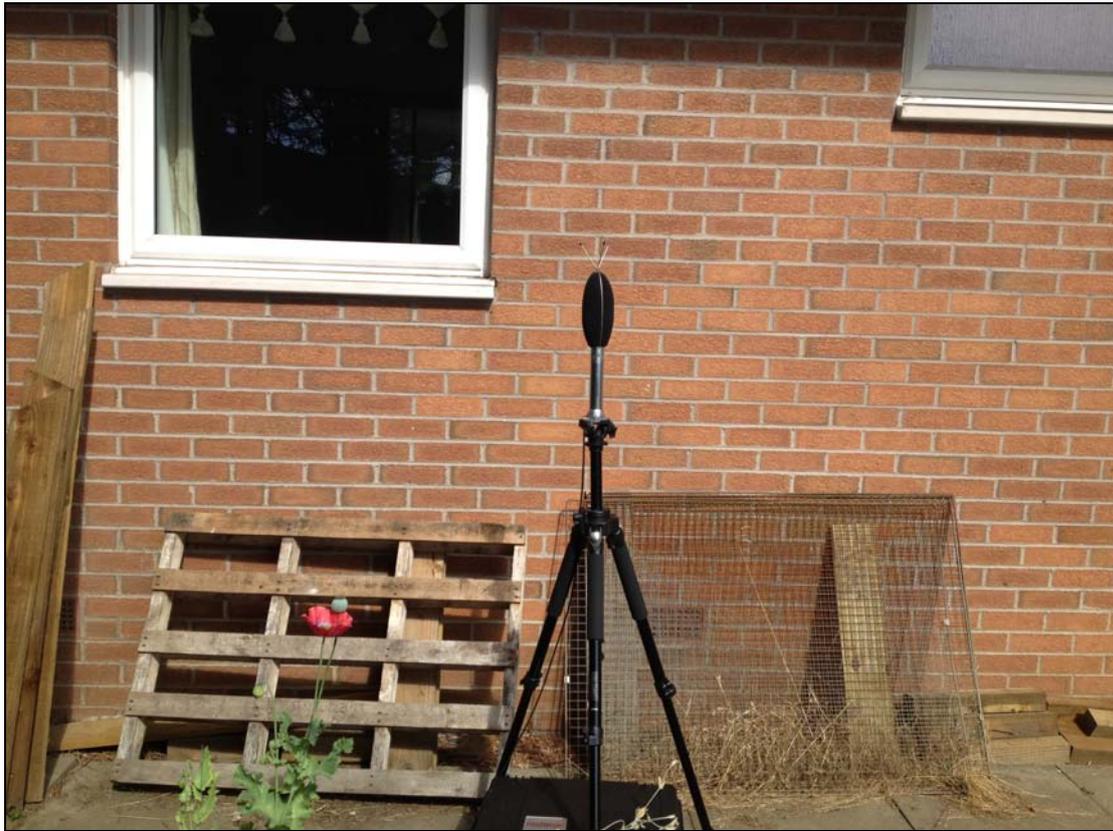
Photograph A.9: Measurement Location at Ochilview

The Brüel & Kjær 2250/2260 sound level meter was secured to a tripod with the microphone 1.5m above the ground, adjacent to the Rion NL-52/Brüel & Kjær 2250 sound level meter. The monitoring equipment was calibrated both before and after the measurement period using an acoustic calibrator, which has itself been calibrated against a reference set traceable to National and International Standards. There was no shift greater than 0.2 dB in the observed calibration level. Fifteen minute snapshot noise level measurements were undertaken with the Brüel & Kjær 2250 throughout the measurement procedure and are shown in Table A.9.

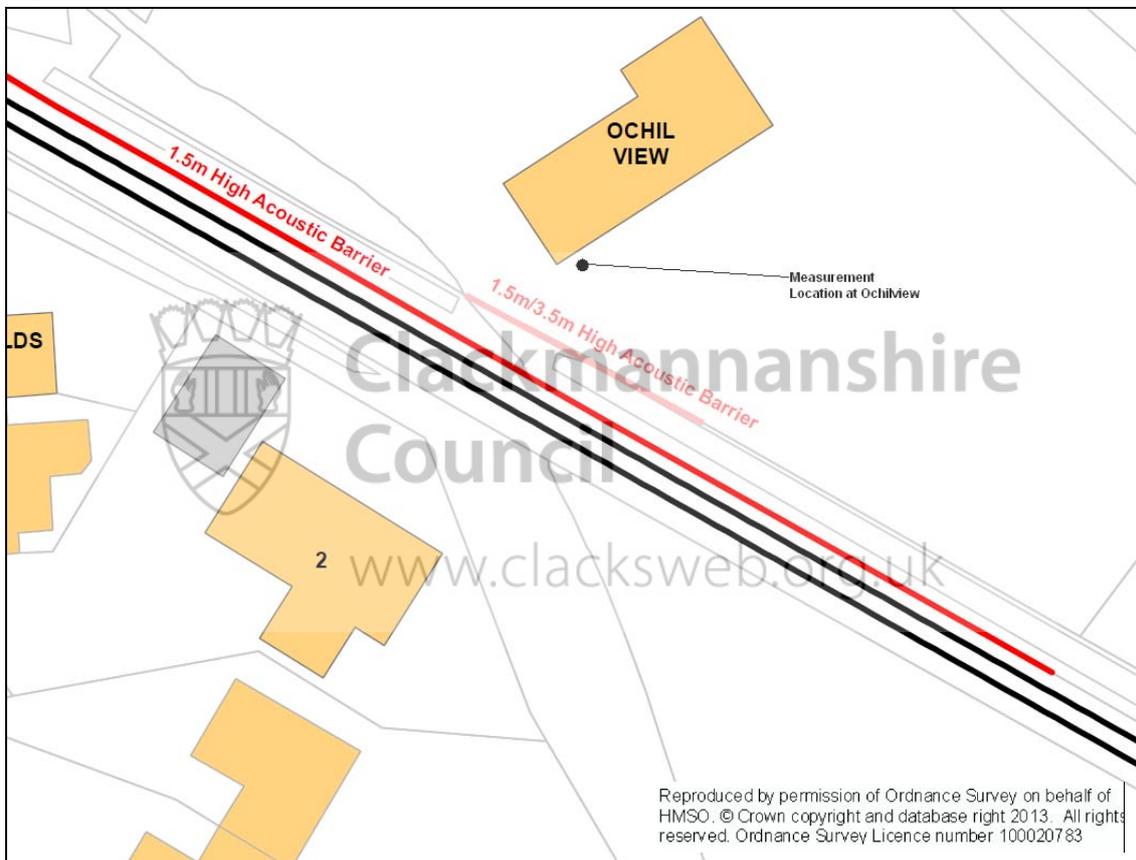
Figure A.9: Measurement Location at Ochilview

The measurement position was located 1m from the south-eastern facing façade, within the rear garden area of the property. This position in turn was approximately 10m from edge of the railway line as shown in Figure A.9. The Rion NL-52/Brüel & Kjær 2250 sound level meter was secured within a weatherproof box with the microphone positioned 1.5m above the ground, see Photograph A.9. The noise monitoring equipment was calibrated both before and after each measurement period using an acoustic calibrator, which has itself been calibrated against a reference set traceable to National and International Standards. There was no shift greater than 0.2 dB in the observed calibration level. The sound level meter was secured at the property and left continuously logging throughout the measurement period.

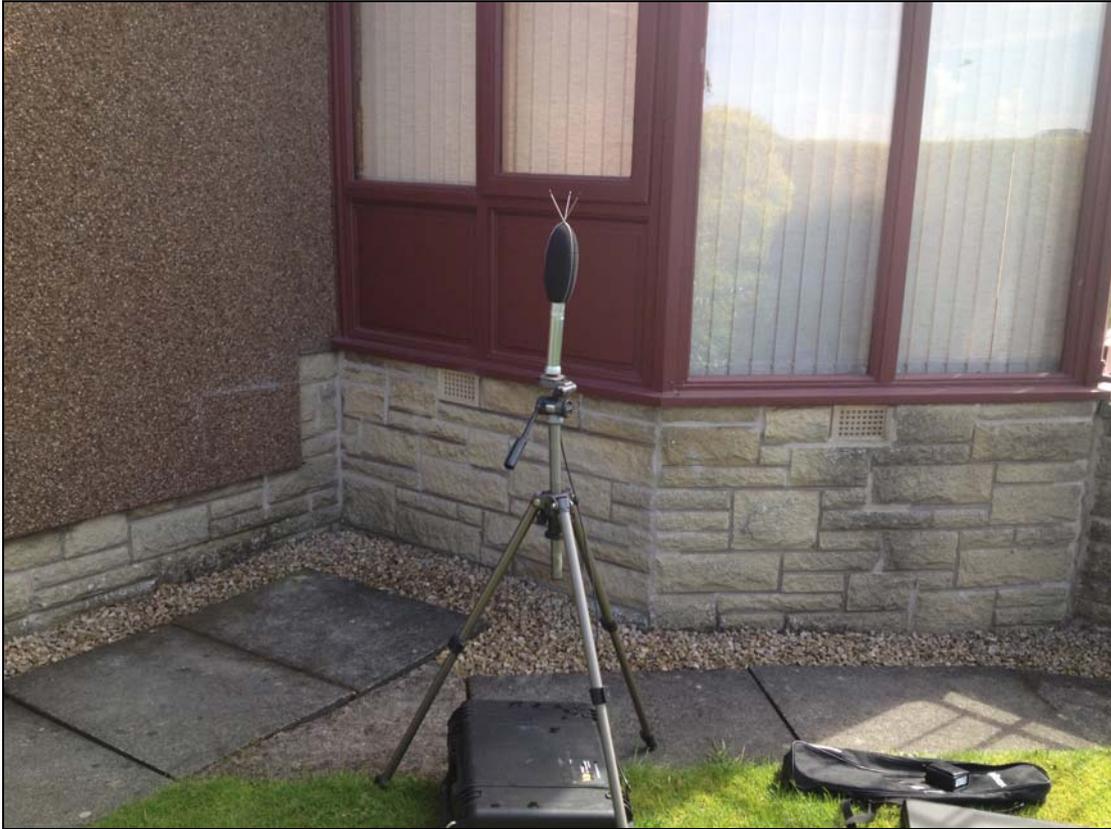
**Photograph A.10: Measurement Location at 16 Ochil View**

The Brüel & Kjær 2250/2260 sound level meter was secured to a tripod with the microphone 1.5m above the ground, adjacent to the Rion NL-52/Brüel & Kjær 2250 sound level meter. The monitoring equipment was calibrated both before and after the measurement period using an acoustic calibrator, which has itself been calibrated against a reference set traceable to National and International Standards. There was no shift greater than 0.2 dB in the observed calibration level. Fifteen minute snapshot noise level measurements were undertaken with the Brüel & Kjær 2250 throughout the measurement procedure and are shown in Table A.10.

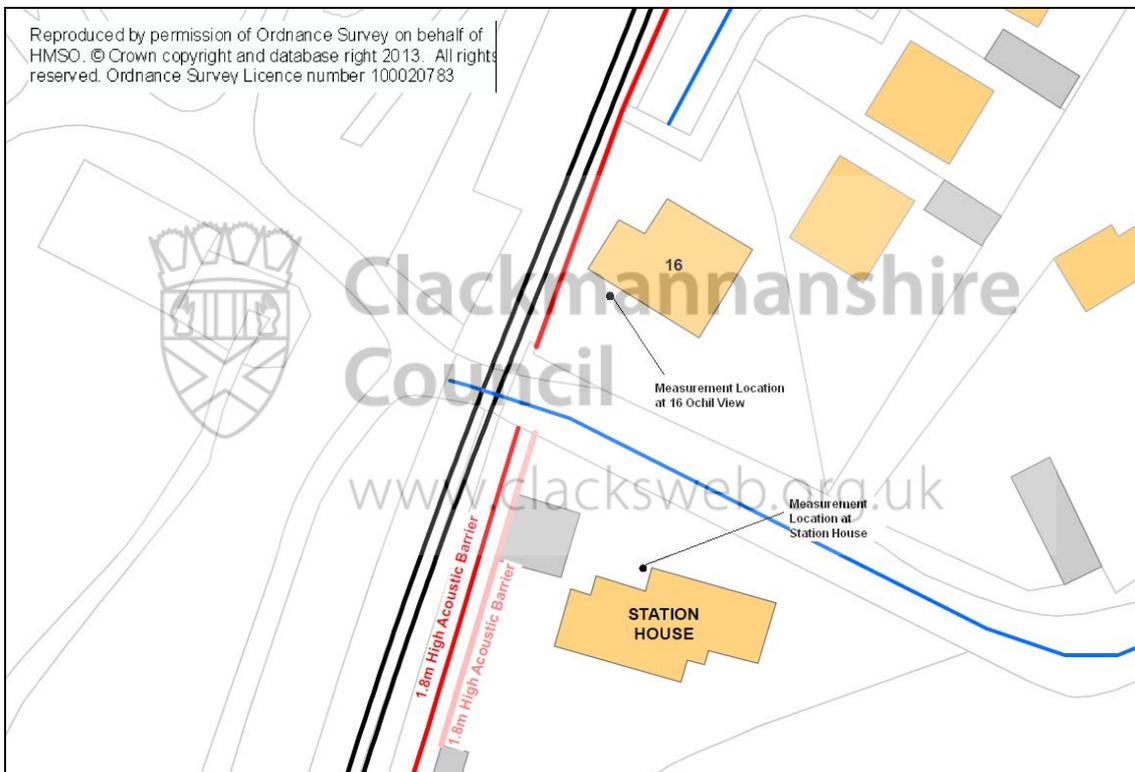
**Figure A.10: Measurement Location at 16 Ochil View**

The measurement position was located 1m from the southern facing façade, within the rear garden area of the property. This position in turn was approximately 6m from edge of the railway line as shown in Figure A.10. The Rion NL-52/Brüel & Kjær 2250 sound level meter was secured within a weatherproof box with the microphone positioned 1.5m above the ground, see Photograph A.10. The noise monitoring equipment was calibrated both before and after each measurement period using an acoustic calibrator, which has itself been calibrated against a reference set traceable to National and International Standards. There was no shift greater than 0.2 dB in the observed calibration level. The sound level meter was secured at the property and left continuously logging throughout the measurement period.

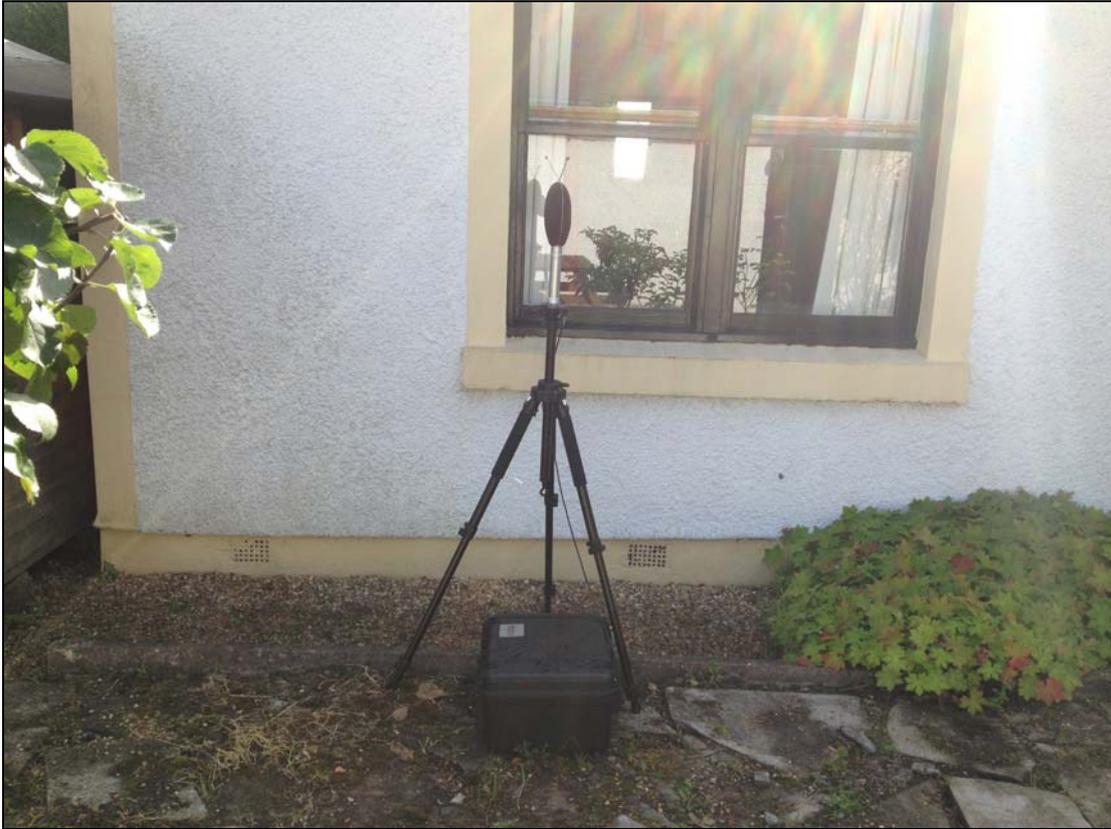
**Photograph A.11: Measurement Location at Station House**

The Brüel & Kjær 2250/2260 sound level meter was secured to a tripod with the microphone 1.5m above the ground, adjacent to the Rion NL-52/Brüel & Kjær 2250 sound level meter. The monitoring equipment was calibrated both before and after the measurement period using an acoustic calibrator, which has itself been calibrated against a reference set traceable to National and International Standards. There was no shift greater than 0.2 dB in the observed calibration level. Fifteen minute snapshot noise level measurements were undertaken with the Brüel & Kjær 2250 throughout the measurement procedure and are shown in Table A.11.

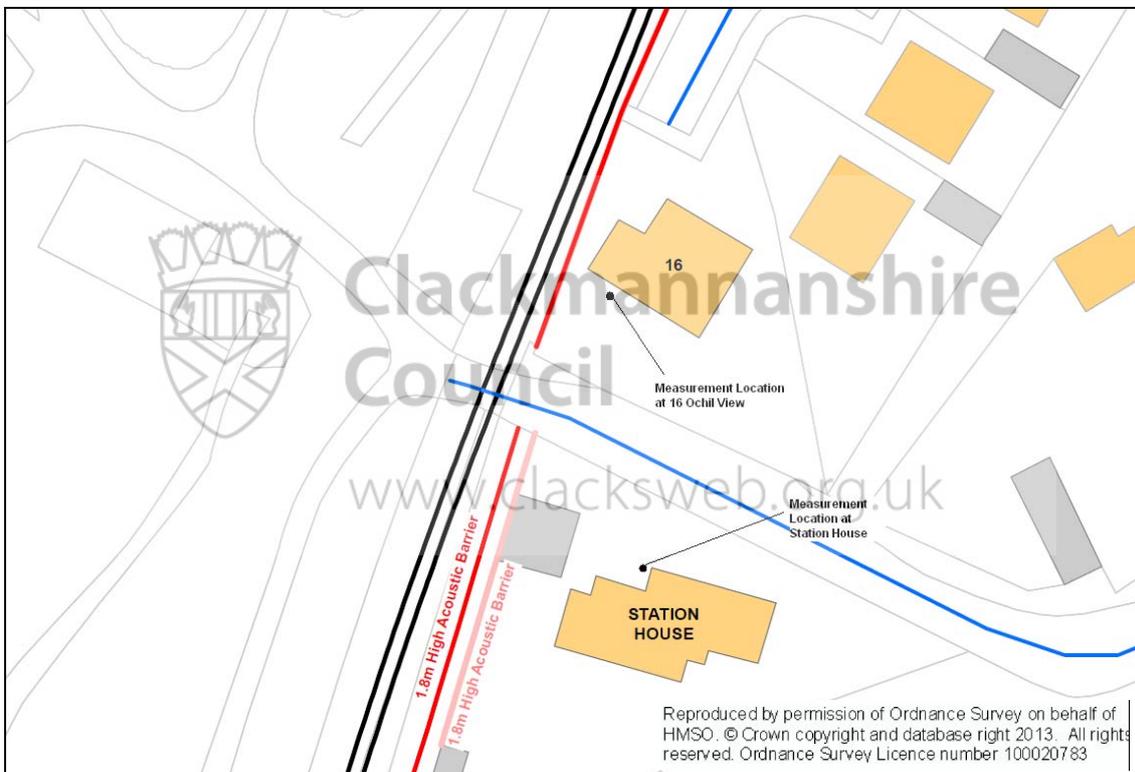
**Figure A.11: Measurement Location at Station House**

The measurement position was located 1m from the southern facing façade, within the rear garden area of the property. This position in turn was approximately 18m from edge of the railway line as shown in Figure A.11. The Rion NL-52/Brüel & Kjær 2250 sound level meter was secured within a weatherproof box with the microphone positioned 1.5m above the ground, see Photograph A.11. The noise monitoring equipment was calibrated both before and after each measurement period using an acoustic calibrator, which has itself been calibrated against a reference set traceable to National and International Standards. There was no shift greater than 0.2 dB in the observed calibration level. The sound level meter was secured at the property and left continuously logging throughout the measurement period.
