TILlicoultry CONSERVATION AREA CHARACTER APPRAISAL

FEBRUARY 2018

Clackmannanshire
Council

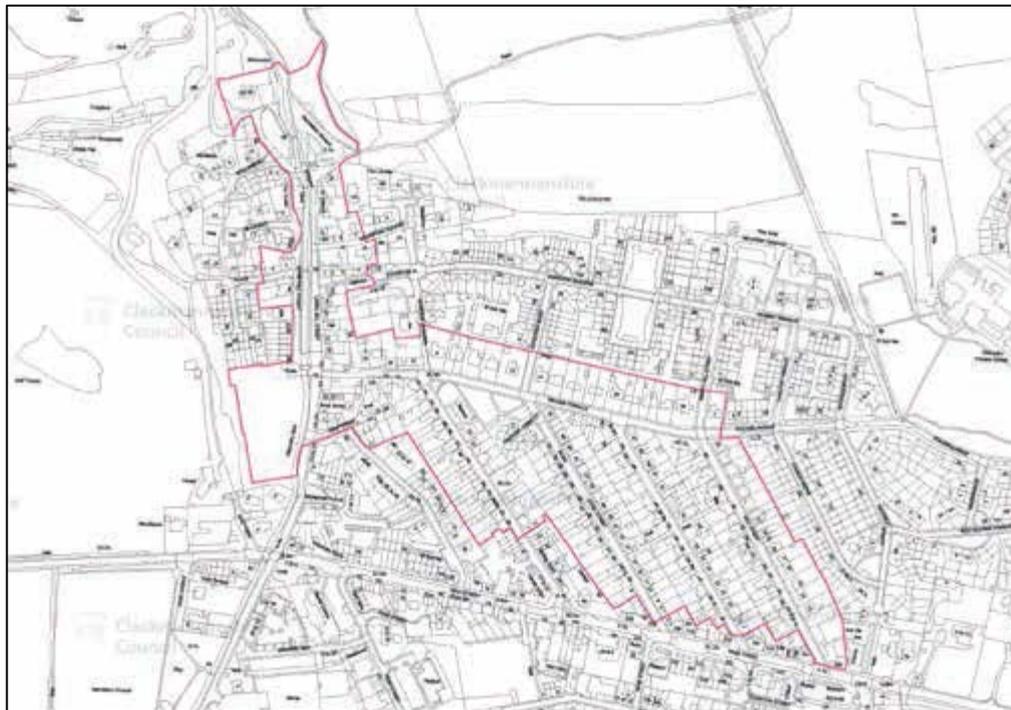
Tillicoultry Conservation Area Boundary

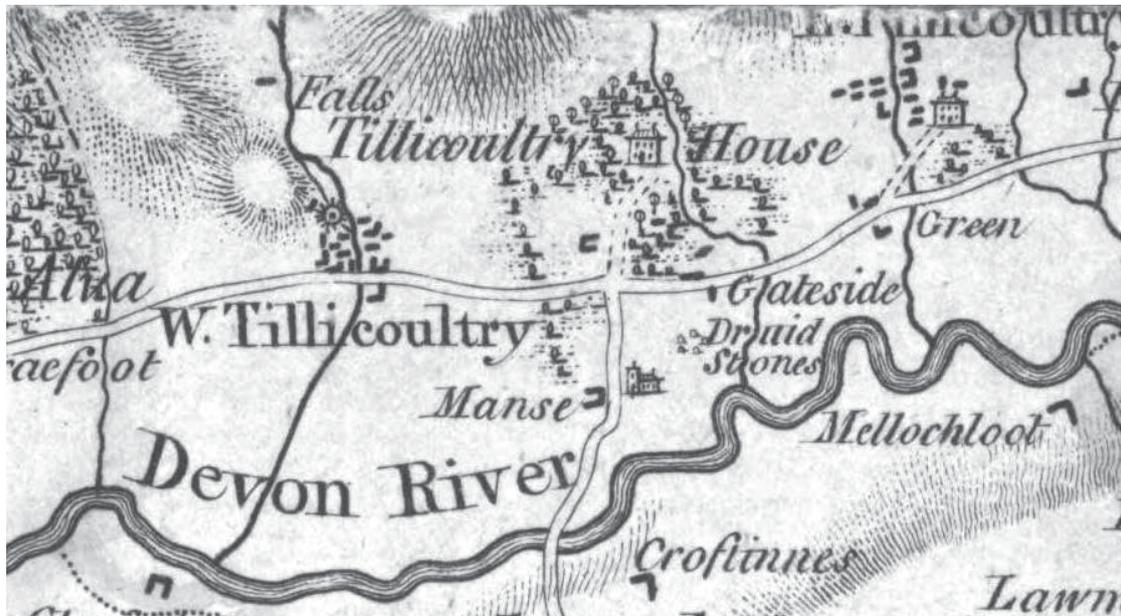
Stobie's map of 1783 shows the old town clustered around the burn where it meets the main road connecting Tillicoultry with the other Hillfoots villages to the east and west.

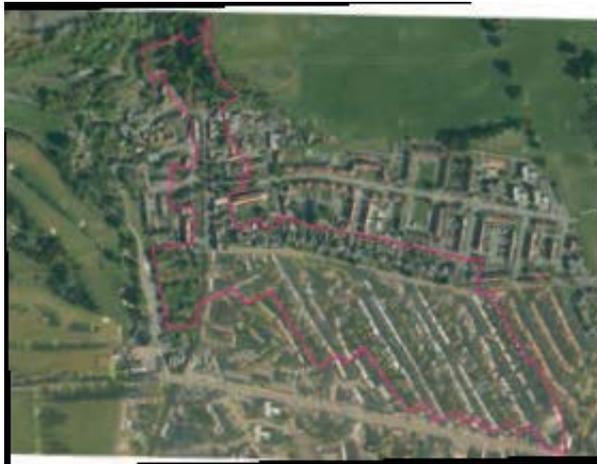
Aerial photograph of Tillicoultry, with conservation area boundary in pink.

The conservation area encompasses Upper Mill Street to the west, with Walker Terrace running perpendicular out towards the east. Stirling Street, Ochil Street, Hamilton Street and Hill Street run approximately southwest from Walker Terrace at an oblique angle. The conservation area boundary skirts around the back of the buildings on High Street, excluding them from the designation.

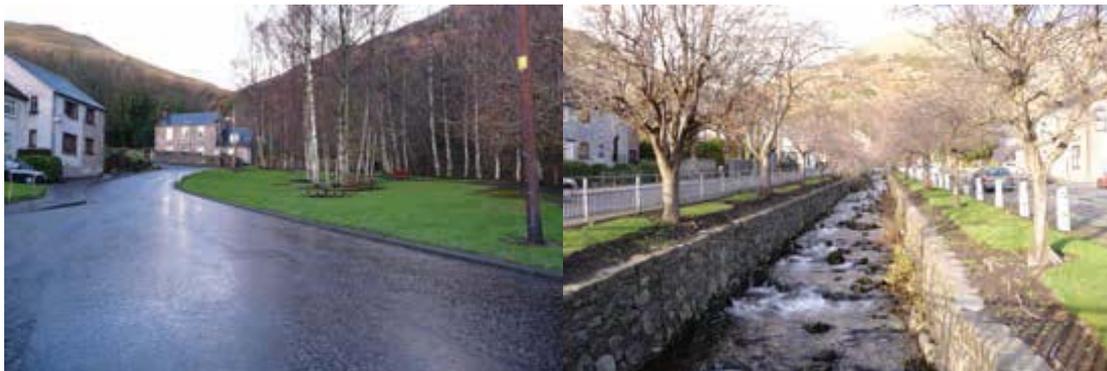
*Left: Open space and trees at Upper Mill Street
Right: Tillicoultry Burn.*

The most significant open space in the conservation area is in Upper Mill Street, focused on the fast moving burn and its rocky bed and grassy banks. (see map 4.1.4). Cherry trees and railings line the banks. To the east side of the burn, the boundary wall is higher, marking the perimeter of the now empty Middleton Mills site.

A recreation ground exists in Upper Mill Street at the entrance to the Mill Glen, with interpretation boards and seating. This contributes to a slightly more picturesque and semi-rural character in this part of the conservation area.

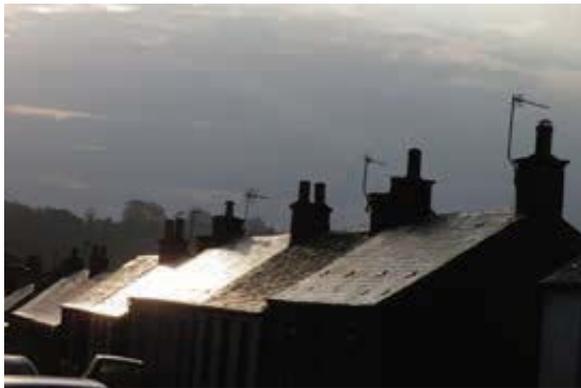
The stepping roofline enlivens street views in Stirling, Ochil, Hamilton and Hill Streets.

Traditionally, roofs are slated with Scottish slate in diminishing courses or covered with clay pantiles, which are common in the Hillfoots villages, occasionally with a slate easing course. The roofs are generally pitched with prominent chimneys at either end and, in some cases skews and moulded skewputts. Prominent chimney stacks are a feature of the conservation area and are particularly striking in the four streets of cottages, where the roofline steps up as the ground rises towards the north.

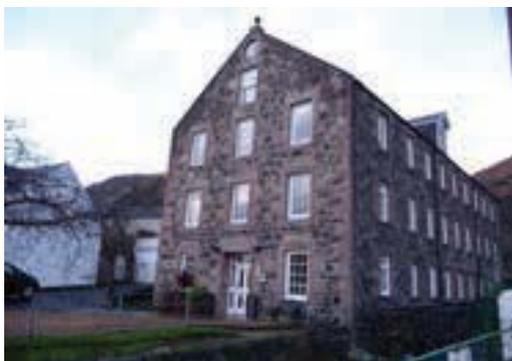
Clock Mill, Upper Mill Street, dated 1824. Rubble walled, 3-storey woolen mill built for JandG Walker. Now converted to flats. Mill was powered from the lade and from an engine house, now gone. The gable, with clock and ball finial is an important feature in views north up Upper Mill Street. Category B-listed.

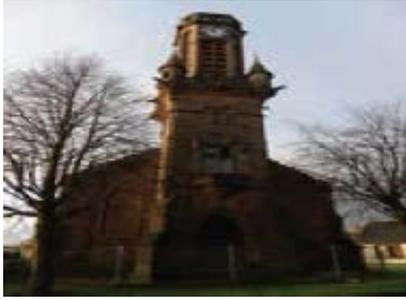
Tower Of Former Popular Institute, Ochil Street, dated 1879. The clock tower was gifted by mill-owner James Archibald as an addition to the Popular Institute, demolished 1986. The tower is the result of a design competition, won by John Melvin and Son. Both the tower and the surviving gable of the Institute are of pinkish sandstone. The tower features diagonal buttresses to the lower stage and a diagonal belfry. Cast iron crown spire now lost. The Tower is currently in need of maintenance and is the subject of a community campaign to repair the landmark structure. Category B-listed.

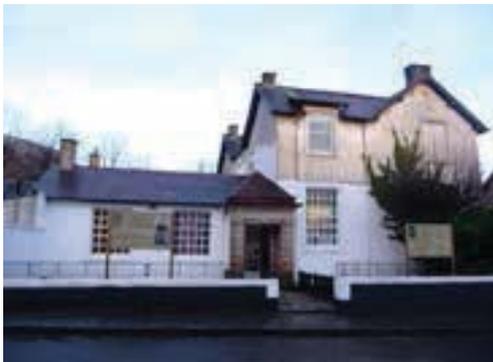
27 Stirling Street, c.1862, extended 1919 by William Kerr & John Gray. Built as the Academy and gifted to the townsfolk by David Paton. Taken over by the Town Council in 1913 as the Walker Institute. Now the premises of McCalls of Daiglen. The main block is two storeys, with painted rubble walling and a single storey extension to north. Large multi-pane windows to Stirling Street. Set back from road slightly behind low boundary wall. Ground floor has been recently repainted. Unlisted.

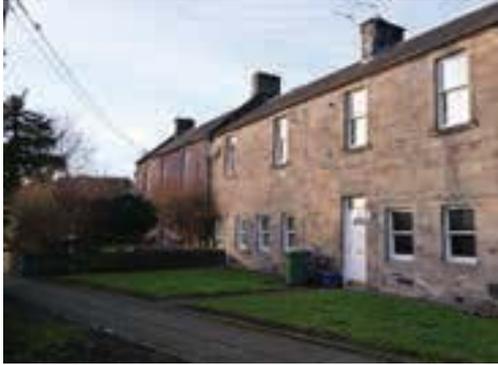
1-7 Cairnton Place, c.1840. 2-storey terrace of former handloom weavers' cottages. In these cottages the looms were on the ground floor, with living accommodation above. No.1 is a 3-bay house, covered in pinkish harl, with surviving timber 6 over 6 sashes. Pitched slate roof, with stone skewes. Gable set directly on Upper Mill Street with low boundary wall to Cairnton Place. No's 2-7 bare rubble walling, with single-pane timber sashes to front elevation. Unlisted.

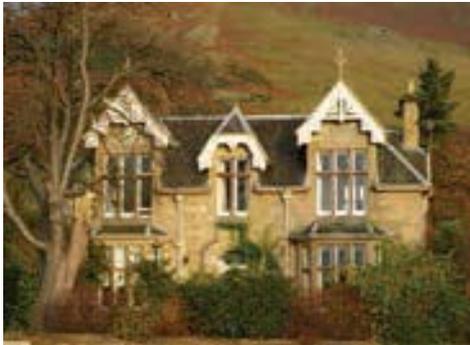
38 Walker Terrace, built 1889, designed by Adam Frame. Originally a manse. Built in buff ashlar sandstone with hipped slate roof. Three wallhead gables to front elevation with decorative barge boards. Central door with bay window either side. Cast iron hoppers on downpipes. Set back from road behind low boundary wall and hedge, in mature gardens. Unlisted.

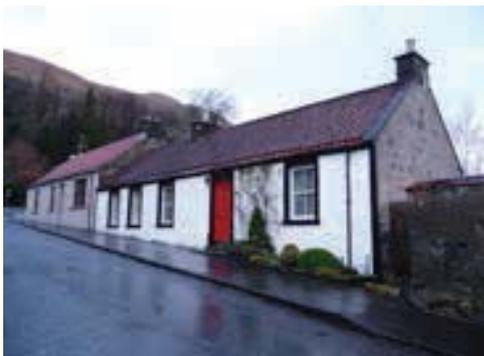
59-63 Upper Mill Street, early 19th Century. Single storey 5-bay weavers' cottage. Loom would have been to lefthand side of the door in the first 3 bays. Two chimney stacks with plain clay pots. Red clay pantiles to roof, with red clay tile easing course. Rubble stone walls, painted white to front elevation, window and door surrounds painted back. Replacement sash windows. Unlisted.

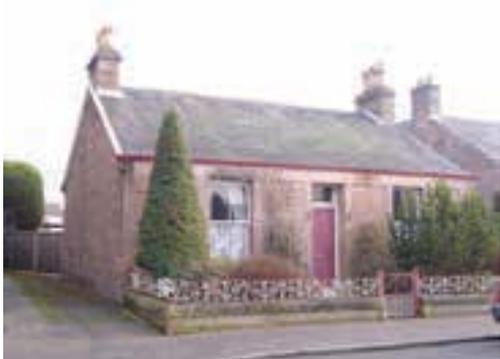
45 Hill Street, late 19th Century. Single storey cottage in pinkish sandstone, tooled and coursed to front elevation, rubble to sides. Possibly original 2 over 2 timber sash windows. Scottish slate roof of diminishing courses with bracketed skewputs and moulded cornice at eaves. Chimney end stacks with decorative yellow clay pots. Low boundary wall topped with modern railings to street. Unlisted.

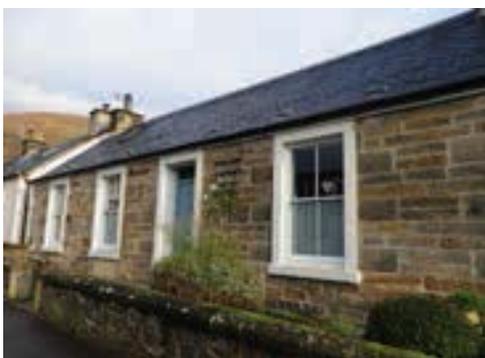
53 Ochil Street, c.1850. Single storey, 4-bay cottage. Timber two over two sash windows. Renewed slate roof with modern rooflight. Snecked tooled sandstone walls with painted window and door surrounds. Low boundary wall and small front garden to Ochil Street. Unlisted.

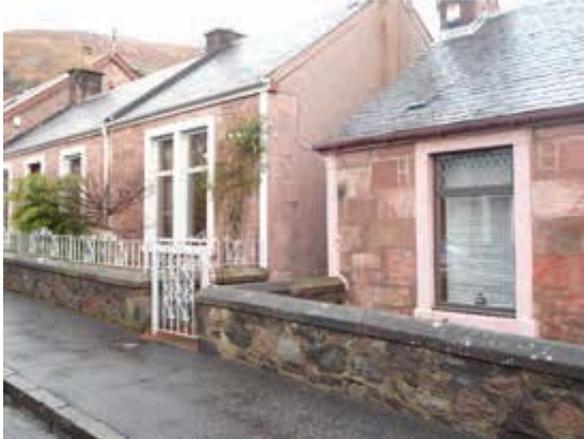
Above: Low boundary walls fronting properties on Ochil Street.

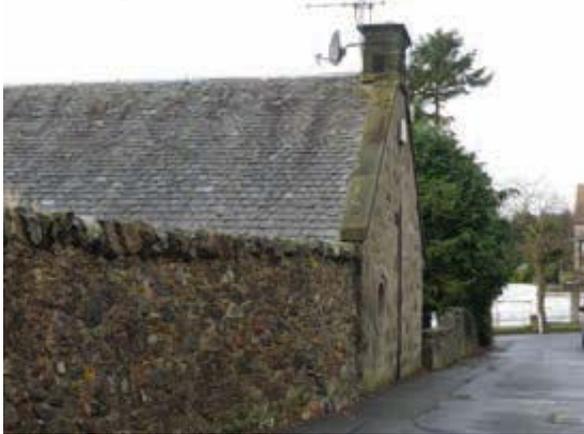
in the 1940s. At the rear of properties walls can be up to 2 metres high and are generally more informal in character, constructed of rubble stonework. Many walls are also combined with hedges.

Below: Higher boundary walling to the rear of a property in Glassford Square.

Boundary walls should be of traditional construction with natural stone and lime mortar.

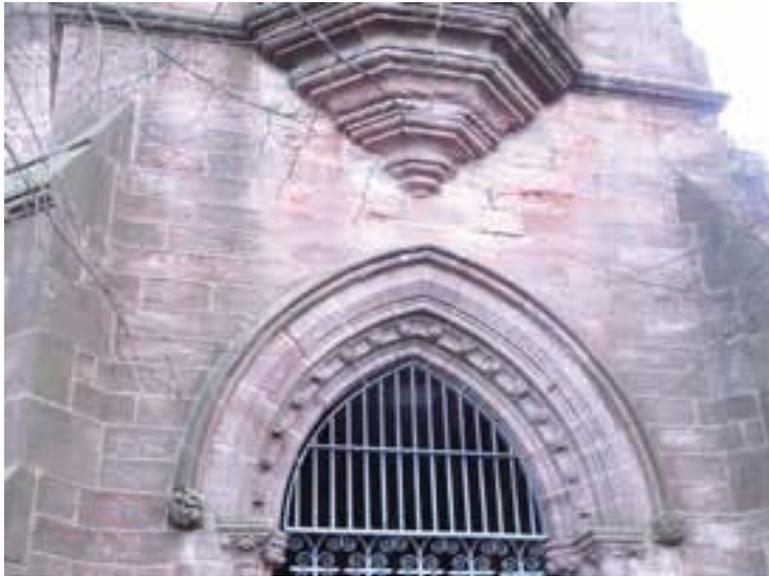
Above: Detail of the Clock Tower.

The Clock Tower is currently in need of maintenance with fencing around its base due to recent loose stonework at a high level. A community-led campaign has been established to secure funding to repair the tower and its clock, in partnership with the local authority who own the structure.

Clackmannanshire Council will continue to work with the local community to secure the future of the Clock Tower, which is currently in need of repair and maintenance.

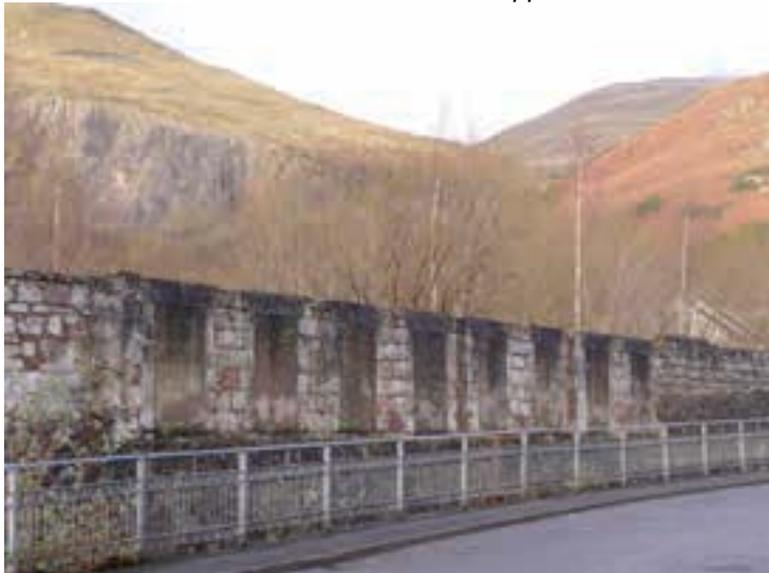
Below: The former Middleton Mills site in Upper Mill Street

The former Middleton Mills site has been cleared and only the perimeter walls and a fragment of the doorway to the office building remain, alongside the burn in Upper Mill Street. The whole site is contained within the conservation area and any development of the site is likely to have an impact on the character of this part of the conservation area and on views around the burn area.

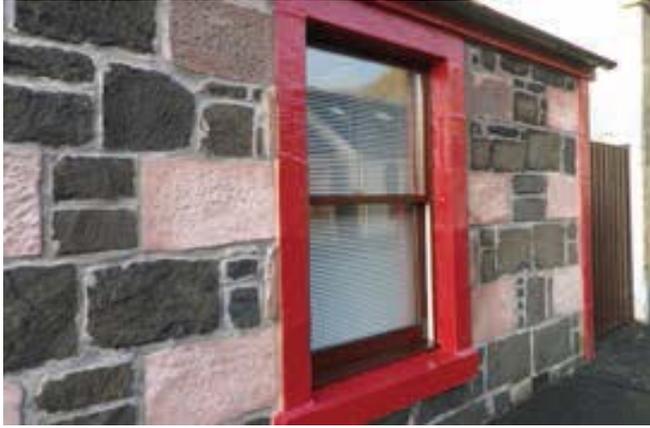
Although the majority of the buildings in the conservation area are in good physical condition the area as a whole is at risk from small changes which can cumulatively dilute the special character of the area. Most houses in the conservation area have now lost their original windows and doors, in many instances stonework has been painted or pebble dashed.

Most traditional properties in the conservation area now have modern replacement windows and doors, often in uPVC.

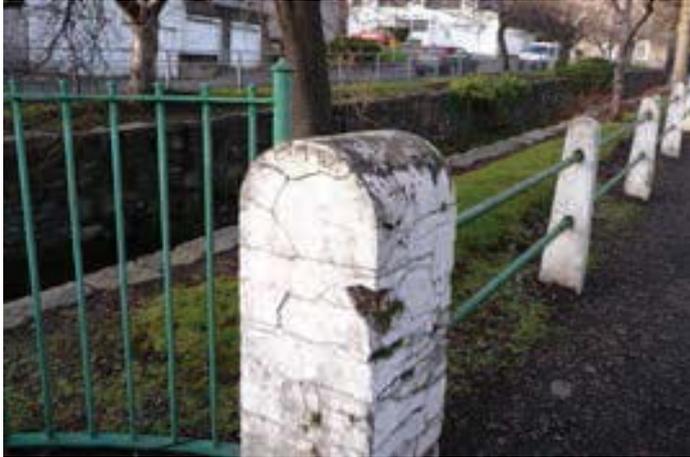
The quality of the public realm in the burn side area, and the utilitarian character of the uncoordinated street furniture do not reflect the character and significance of the conservation area. The tight urban form with small front gardens and housing fronting immediately onto the road results in limited parking provision for many residential properties. It is vital to ensure that public works and traffic management measures do not detract from the otherwise high quality historic environment. There may be opportunities to improve the surfacing and provision and quality of street furniture.

Public realm in some place appears tired and neglected

The Council will also consider opportunities to replace existing street furniture with designs which reflect the locality, using traditional, local construction techniques and materials and/ or local craftspeople.

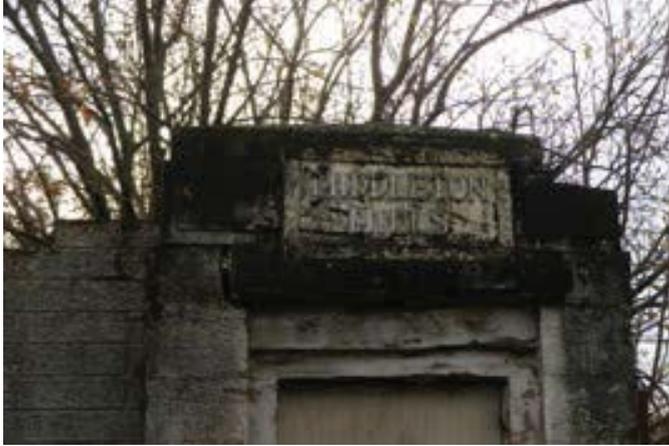
Surviving doorway at the former Middleton Mills site

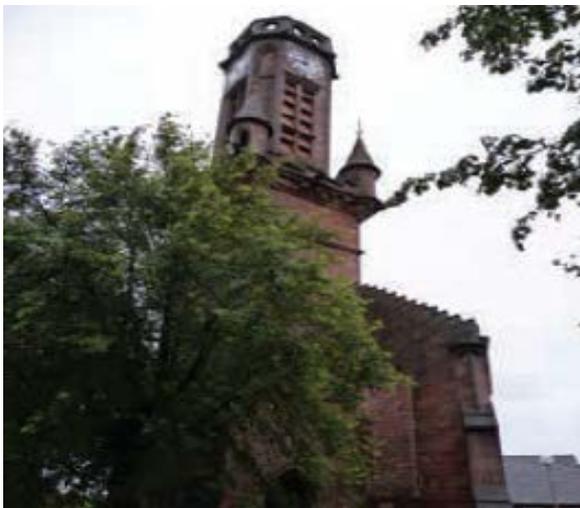
The Clock Tower is in need of repair and maintenance

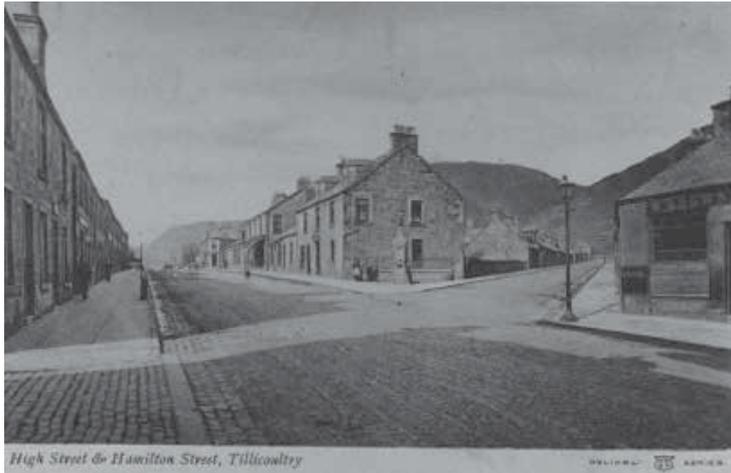
The boundary will be extended on the western side of Hamilton Street southwards to include the 2-storey 19th Century property at 124 High Street, in the centre of this historic image. (Image copyright of Clackmannanshire Council)

- Extend the boundary on the western side of Ochil Street south to include the corner block at 102 High Street.
- Extend the boundary on the western side of Hamilton Street south to include the 2-storey 19th Century property at 124 High Street. See historic photograph below.
