REPORT FOR - Dumyat Leisure Centre

Dumyat Leisure Centre

1.0 Dumyat Leisure Centre

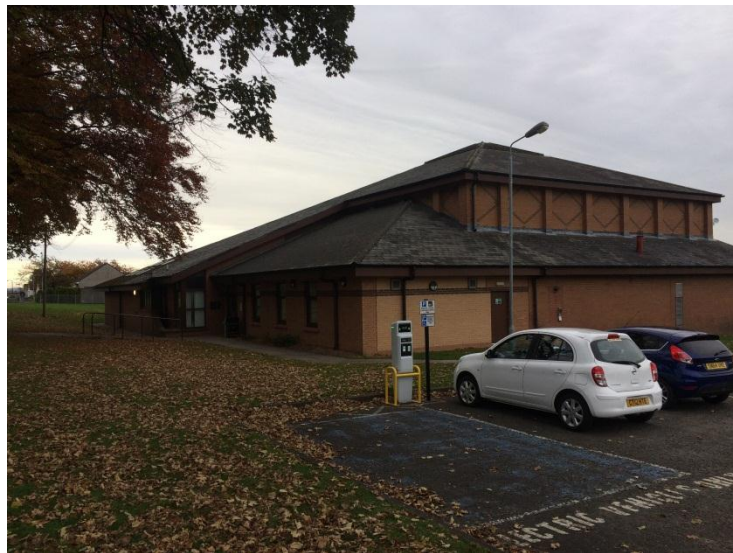
Dumyat leisure centre is a multi use property situated within Menstrie, housing a library sports hall and meeting areas used for the community. Built with structural steelwork to the main sports hall and traditional brickwork and block for the surrounding library and rooms, glazed with powder coated timber cilled windows and mineral tile roof. The property was constructed circa 1995 and has a GIA of 1418m².
